Spokane Register of Historic Places Nomination

Historic Name: Trolan, Daniel and Mary Ann, Homestead
Common Name: Trolan-Ellsworth Property; Trolan-Ellsworth House; Ellsworth, Fred and Lula M., Farm; Ellsworth, Freddie and Velma, Farm; Long, Connie and James, Farm

Street & Number: 7701 W. Cross Cut Rd.
City, State, Zip Code: Deer Park, WA 99006
Parcel Numbers: 28321.9015, 28321.9016

Name and Title: Ann Sharley, Senior Architectural Historian

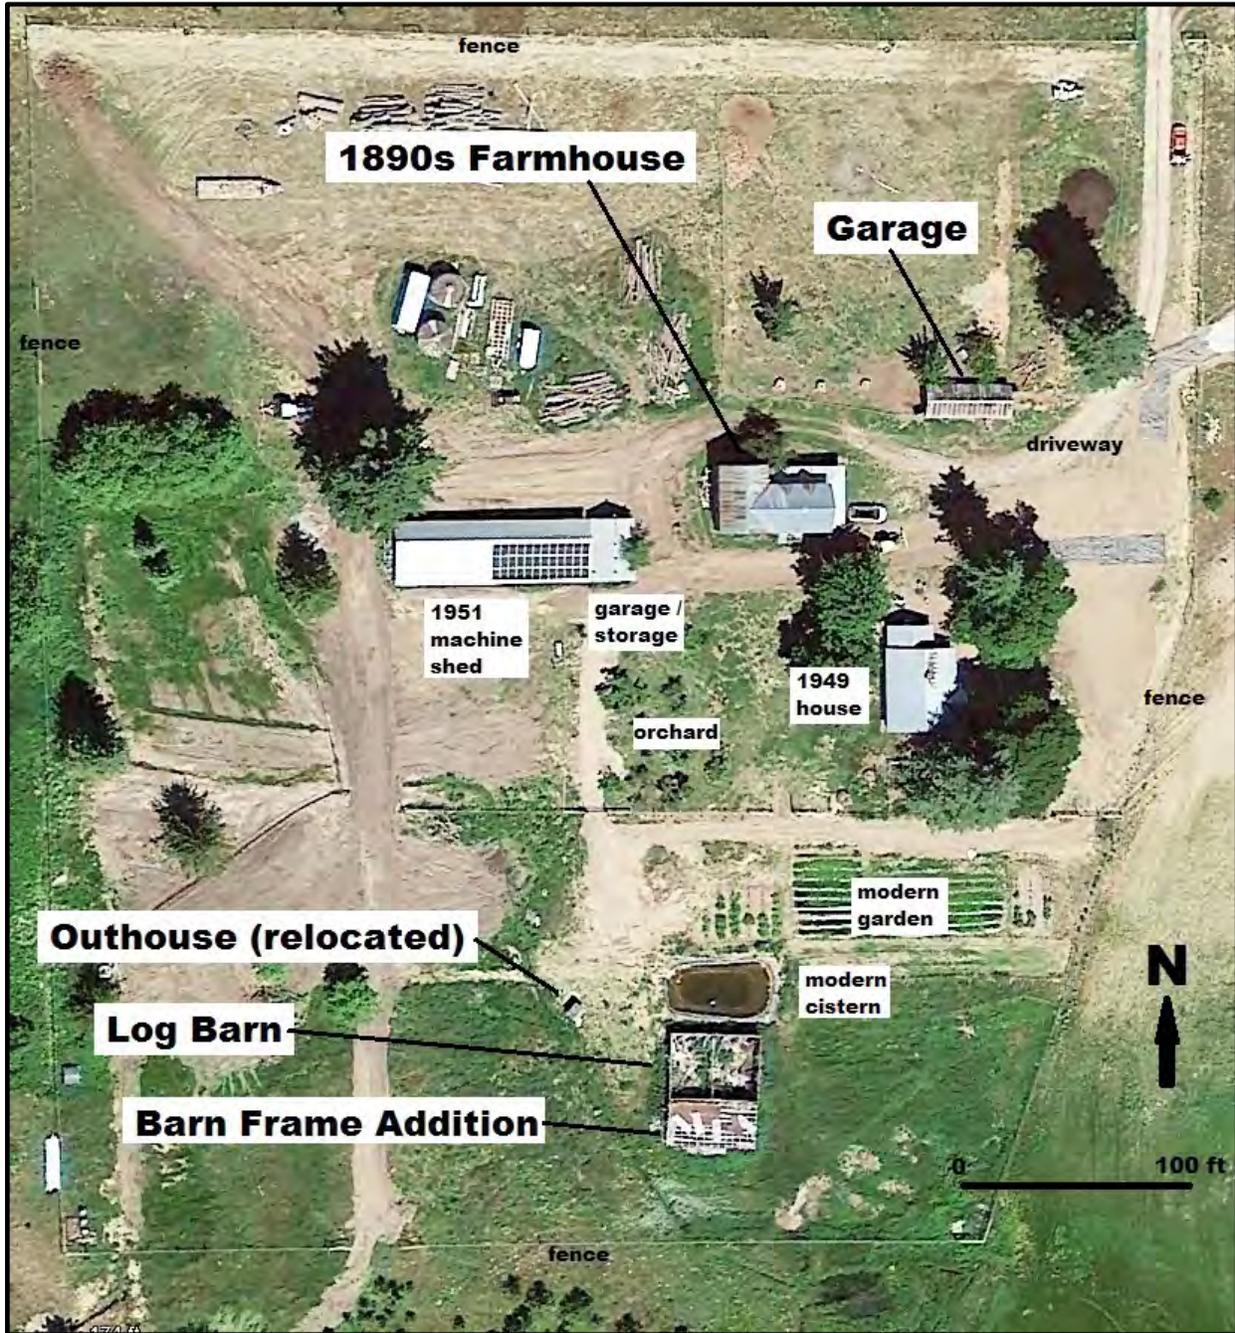
Figure 2. Trolan Homestead (Trolan Homestead/Ellsworth Farm) buildings and features, 7701 W. Cross Cut Road, Deer Park (adapted from Google Earth aerial photograph, 2017).

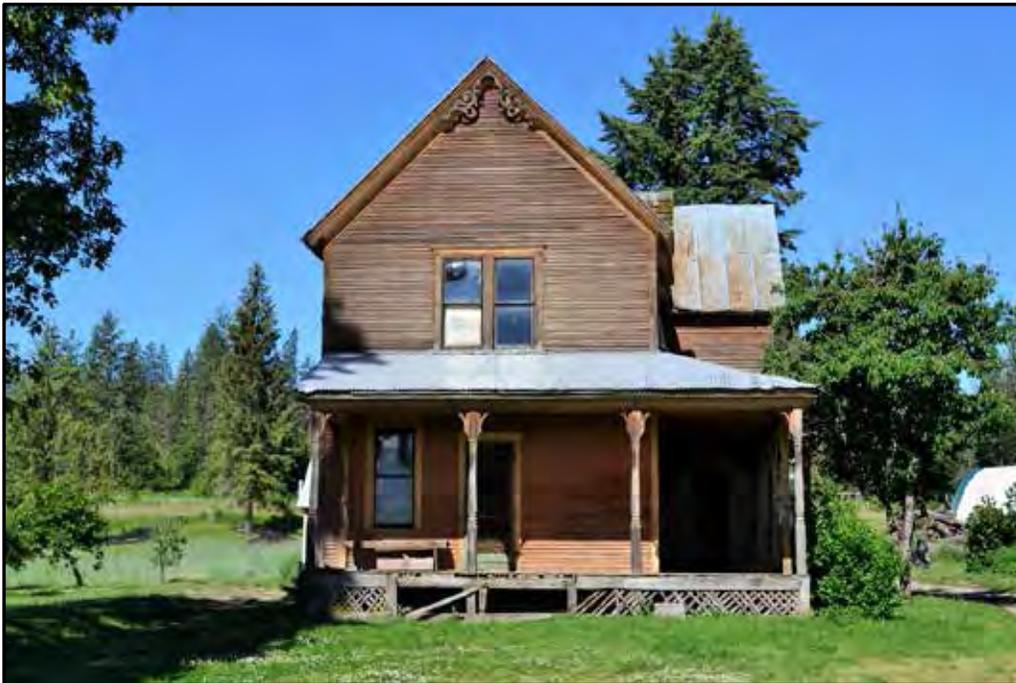
Figure 8. 1890s Farmhouse, east/front elevation.

This large two-story cross-gabled wood frame house, L-shaped in plan, is oriented east-west and north-south based on true compass directions (Figures 3 to 47). The building consists of a simple rectangular western section, 18 feet wide and 26 feet long, and an eastern (now front) cross-gabled wing, also 18 feet wide and 26 feet long. The western section may have been built first and the eastern wing added later: a vertical seam, visible on the south side of the building where loss of siding has exposed the diagonal sheathing, marks the juncture of the two building sections. Identification of rooms within the house, with labels such as “possible dining room” and “probable bedroom,” is based on room size, location, ornament, and existing features. Although the complete label is provided in Figure 3, the qualifiers “possible” and “probable” are omitted from the report text to increase readability.

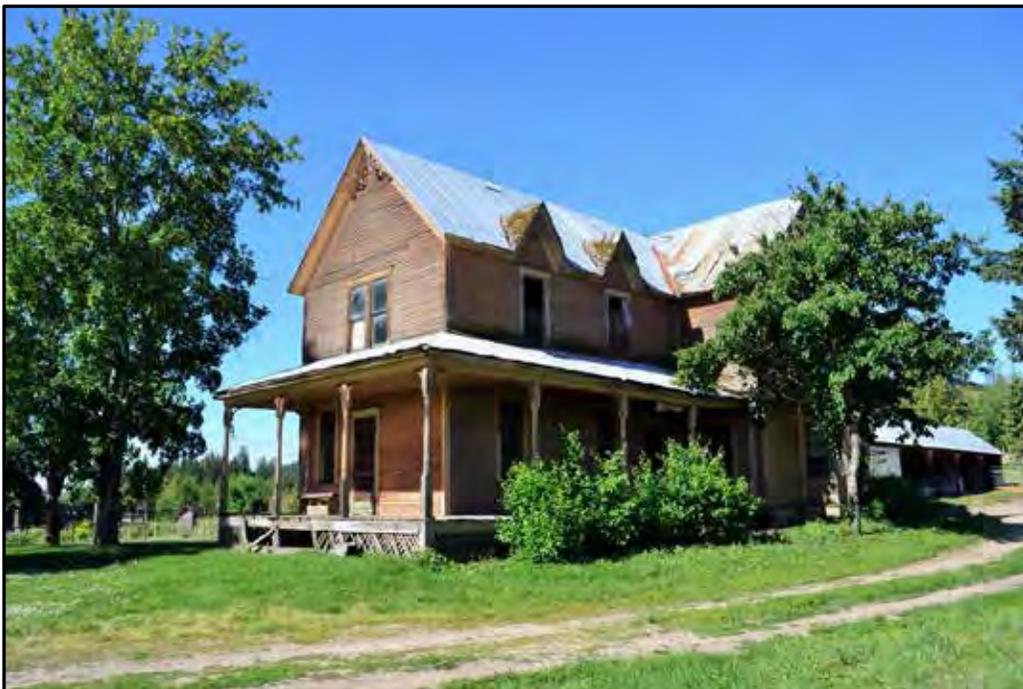
Figure 9. 1890s Farmhouse, east/front and north sides.

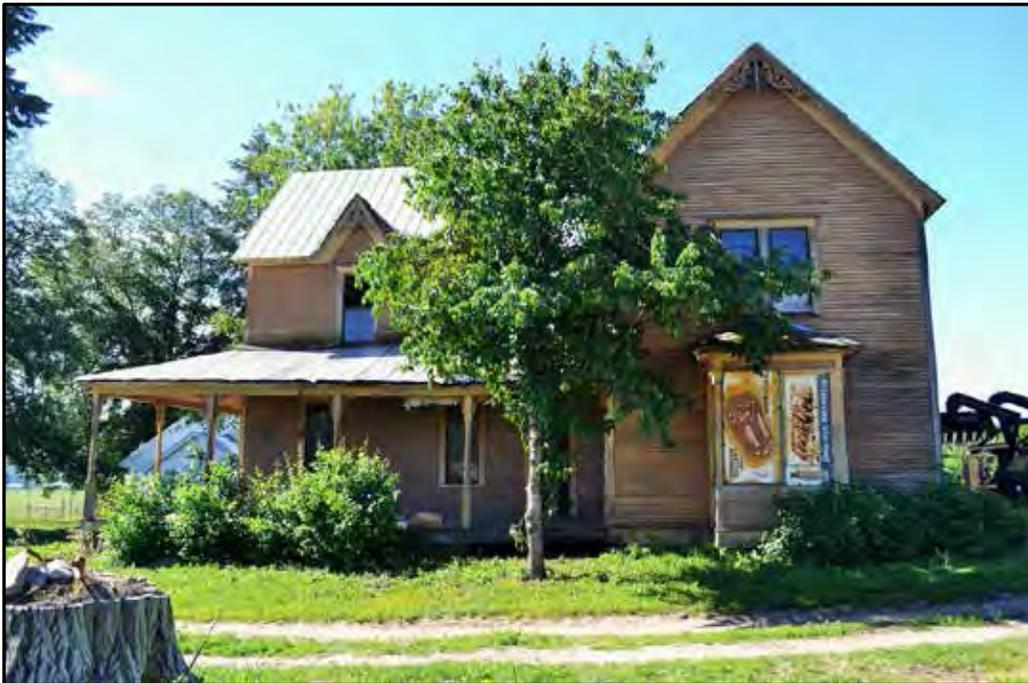
Figure 10. 1890s Farmhouse, north elevation.

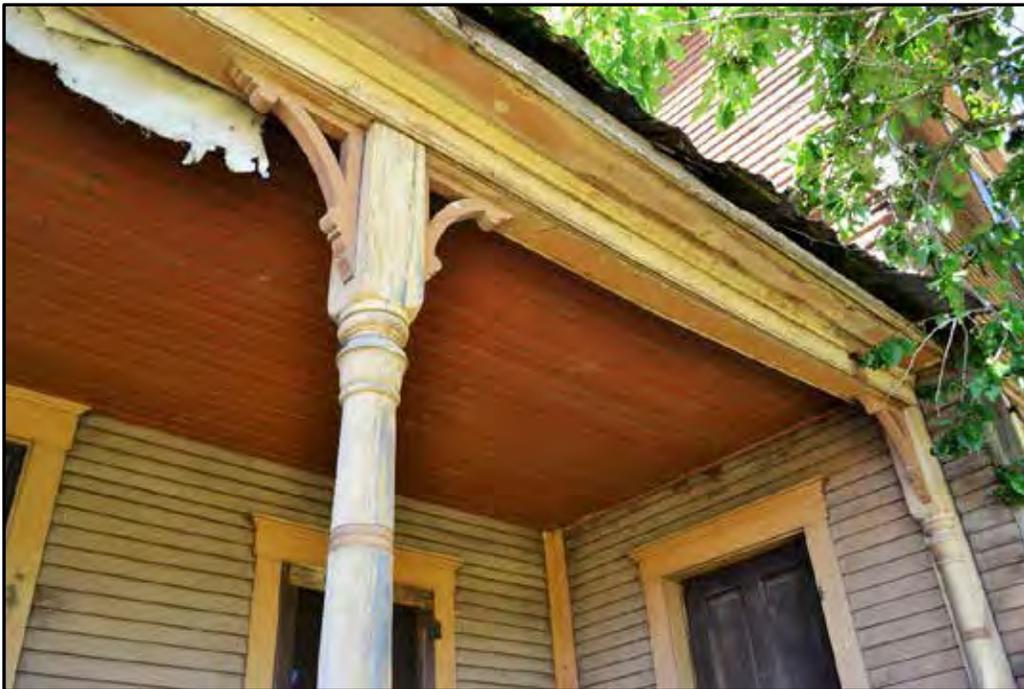
Figure 19. 1890s Farmhouse, detail of wraparound front porch on east section's north side; view to the southwest.

A seven-foot wide wraparound front porch with 3.5-inch tongue and groove decking extends across the entire front (east) and north sides of the east wing. A low-pitched hip-

roofed porch canopy with boxed eaves is supported on turned wooden posts with jigsaw cut ornament, five posts across the front and five across the north side (the corner post is counted twice in this tally); the end posts, one on the front (east) and one on the north side, are half posts (engaged columns) attached to the building face. Latticework covers the space between the porch deck and the ground, while the front steps are currently missing.

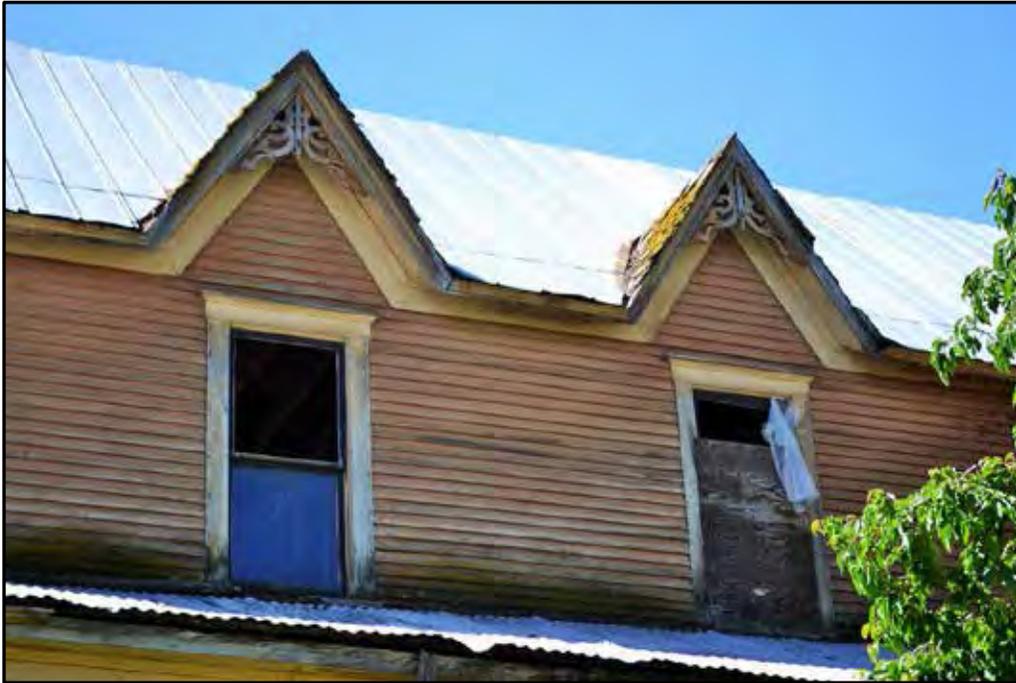
Figure 20. 1890s Farmhouse, detail of cross-gables on east section's north side; view to the southwest.

The roof on both sections of the house is steeply pitched with moderately overhanging rakes and moderately overhanging boxed eaves. The eaves are ornamented with wood molding fascia, and wood molding and board trim on the building face beneath the eaves and rakes adds additional decorative interest. Jigsaw-cut ornament with a turned pendant originally decorated the peak of each gable, although portions of these elements are now deteriorated or missing. Two prominent cross-gables, both with jigsaw-cut ornament and a turned pendant, embellish the highly visible north side of the eastern wing, each centered above a wood sash double-hung second story window. Wood shingle roofing, now deteriorated, is covered in places with corrugated galvanized sheet metal or modern standing seam sheet metal. The building originally had two chimneys, one slightly south of center on the west section’s roof crest and one slightly east of center on the east section’s roof crest. Both have now been removed and the openings covered with sheet metal.

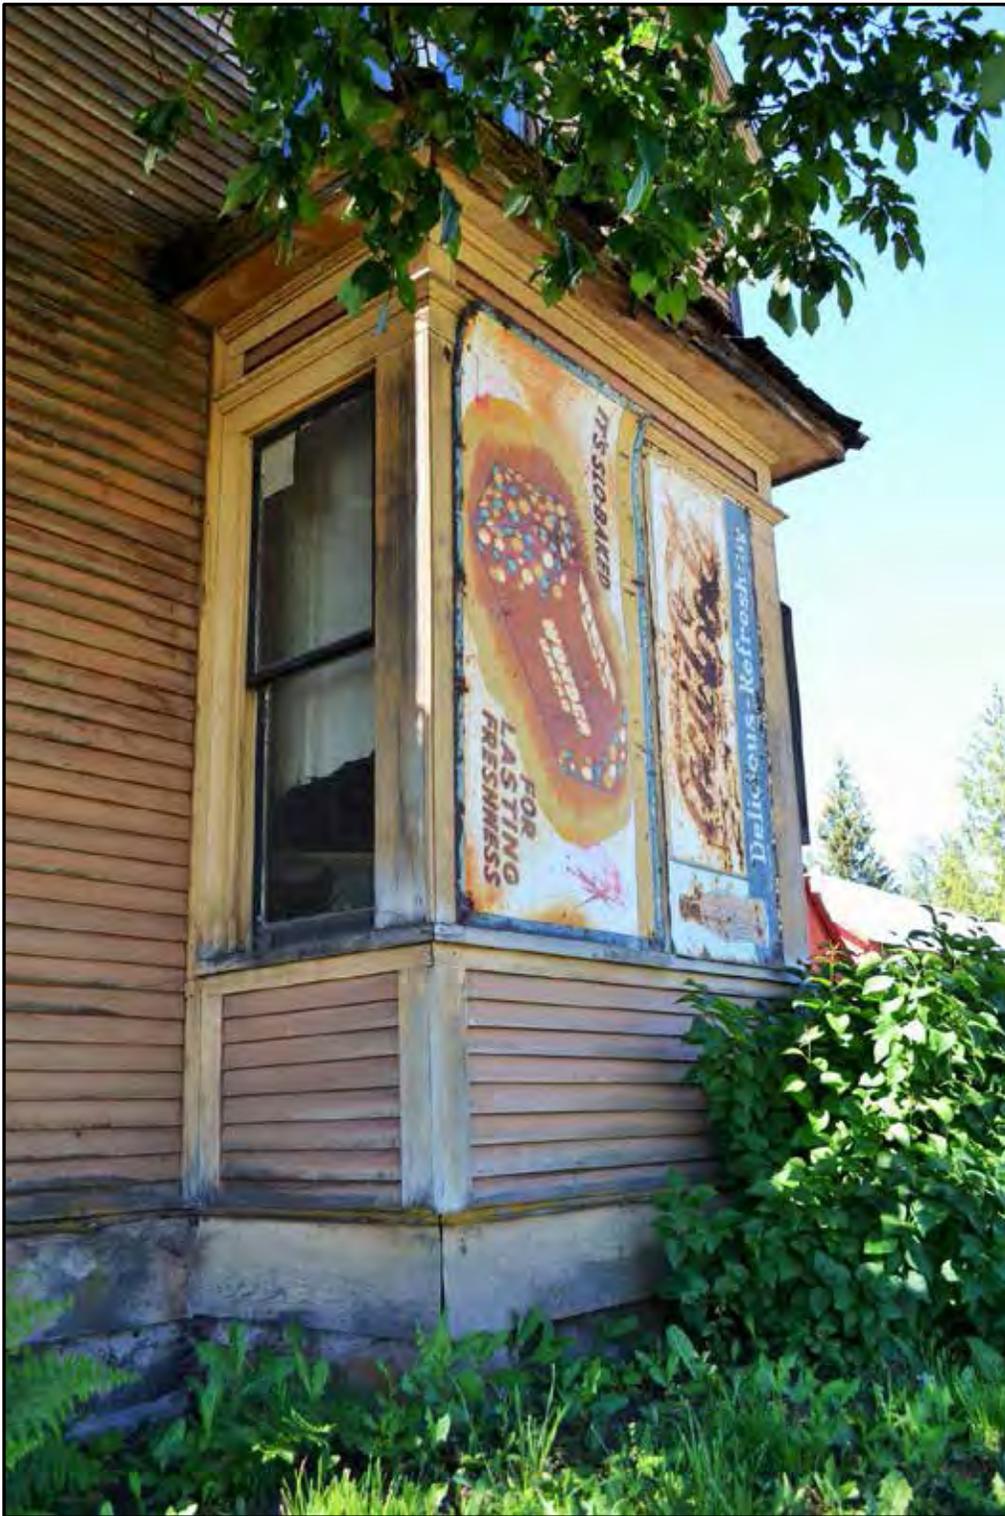
Figure 22. 1890s Farmhouse, detail of bay window on west section's north side; view to the southwest.

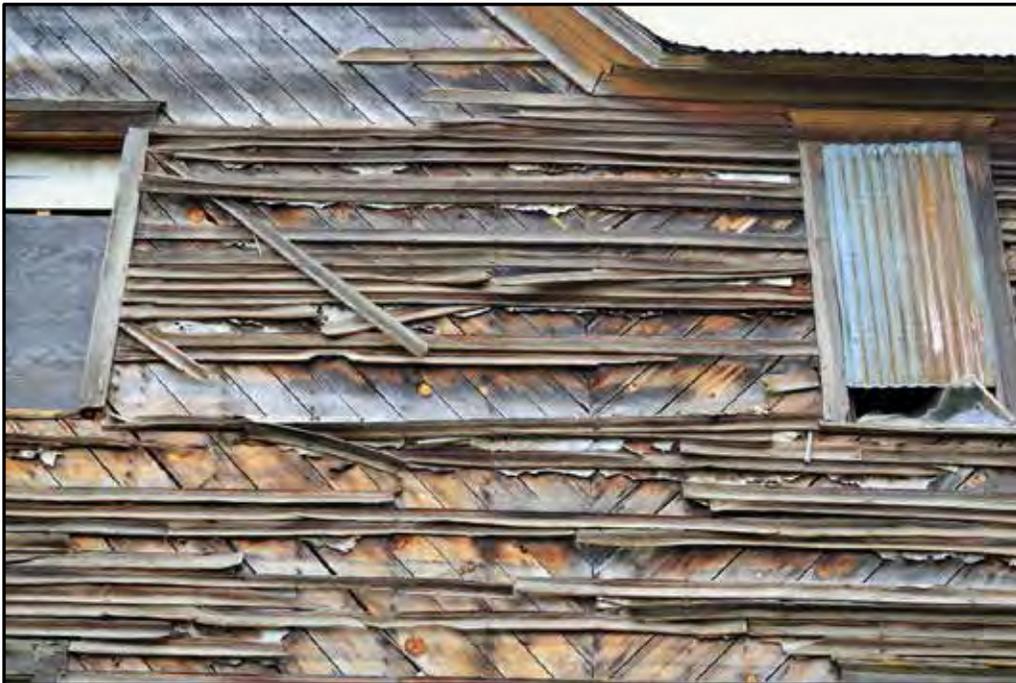
Figure 23. 1890s Farmhouse, detail of seam between west and east sections of house; view to the north.

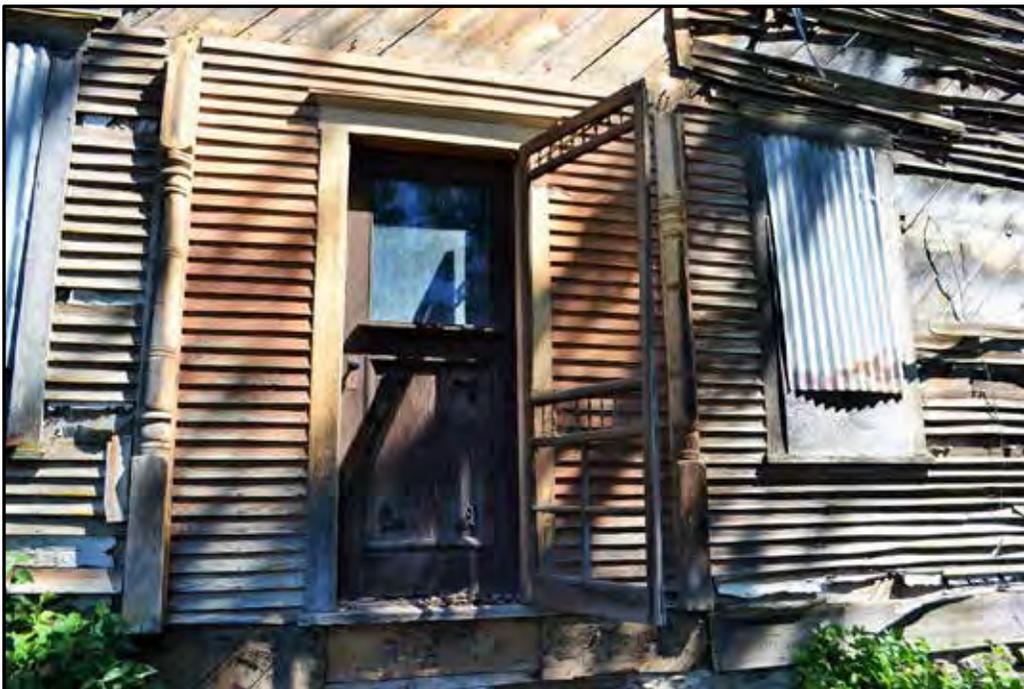
Figure 24. 1890s Farmhouse, detail of south door and remnants of removed porch; view to the northeast.

The front (east) door, an original wood panel unit with an ornate cast metal escutcheon plate and black glass knob, is centered on the east face of the eastern wing. An original screen door at this entrance features two bands of turned spindlework ornament, an original metal latch, and ornate cast metal hinges embossed "SHELBY". Another wood panel door with an ornate escutcheon plate and black glass knob opens into the living room (#5 on Figure 3) from the northern wraparound porch, while a panel and glass door with an original escutcheon plate and black glass knob opens into the dining room (#2 on Figure 3) from the northern wraparound porch. Although the small south porch has been removed, the door – a wood panel and glass unit with four small leaflike wood ornaments attached to the panel, an ornate escutcheon plate, and black glass knob – remains, flanked by two turned spindlework half posts attached to the building face. This entrance is provided with an original screen door with turned spindlework ornament similar to that of the front (east) screen door but with simple metal hinges. A native stone foundation outlines the footprint of the former porch deck.

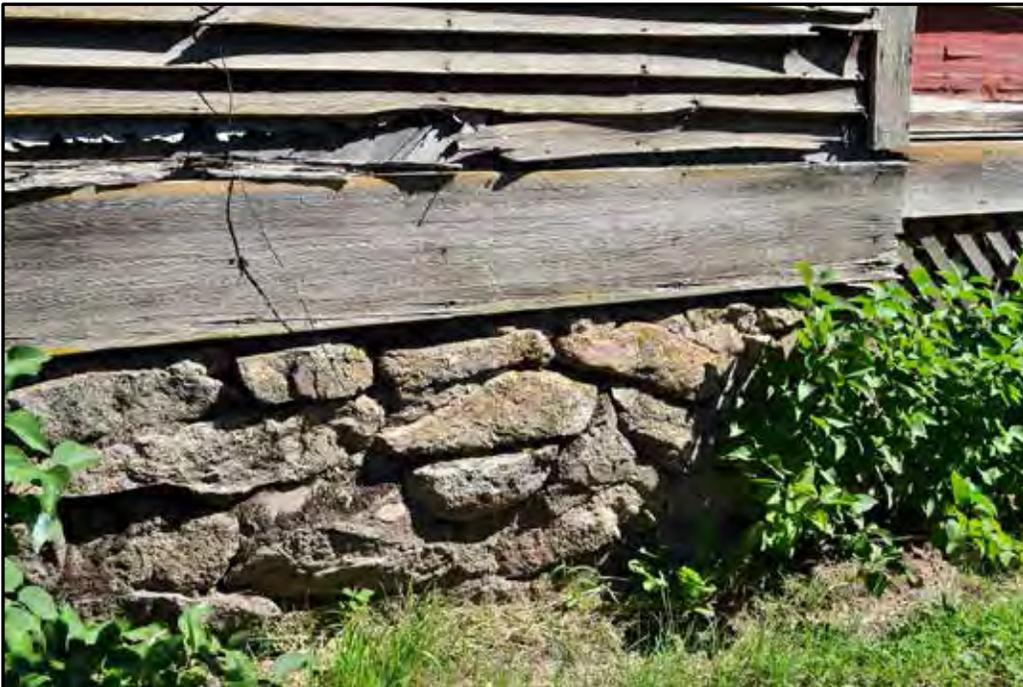
Figure 26. 1890s Farmhouse, detail of stone foundation on east section's south side; view to the northeast.

The 1890s farmhouse rests on a mortared stone foundation, composed of uncoursed and unshaped native stone, mostly granite, ranging from six inches to two feet in diameter. Cladding is horizontal lapped 3.5-inch wide beveled boards with 4-inch wide vertical cornerboards and 10-inch wide horizontal boards at the base of the walls. Remnant paint can be seen in places, although fading may have altered the original colors: orangish-tan cladding, porch post horizontal bands, and porch post jigsaw ornament; yellowish porch posts, cornerboards, and window/door trim; greenish trim under the eaves on the south side of the house; and a green front (east) screen door.

Original native stone foundation or, if needed, replacement with a foundation that appears similar to the original

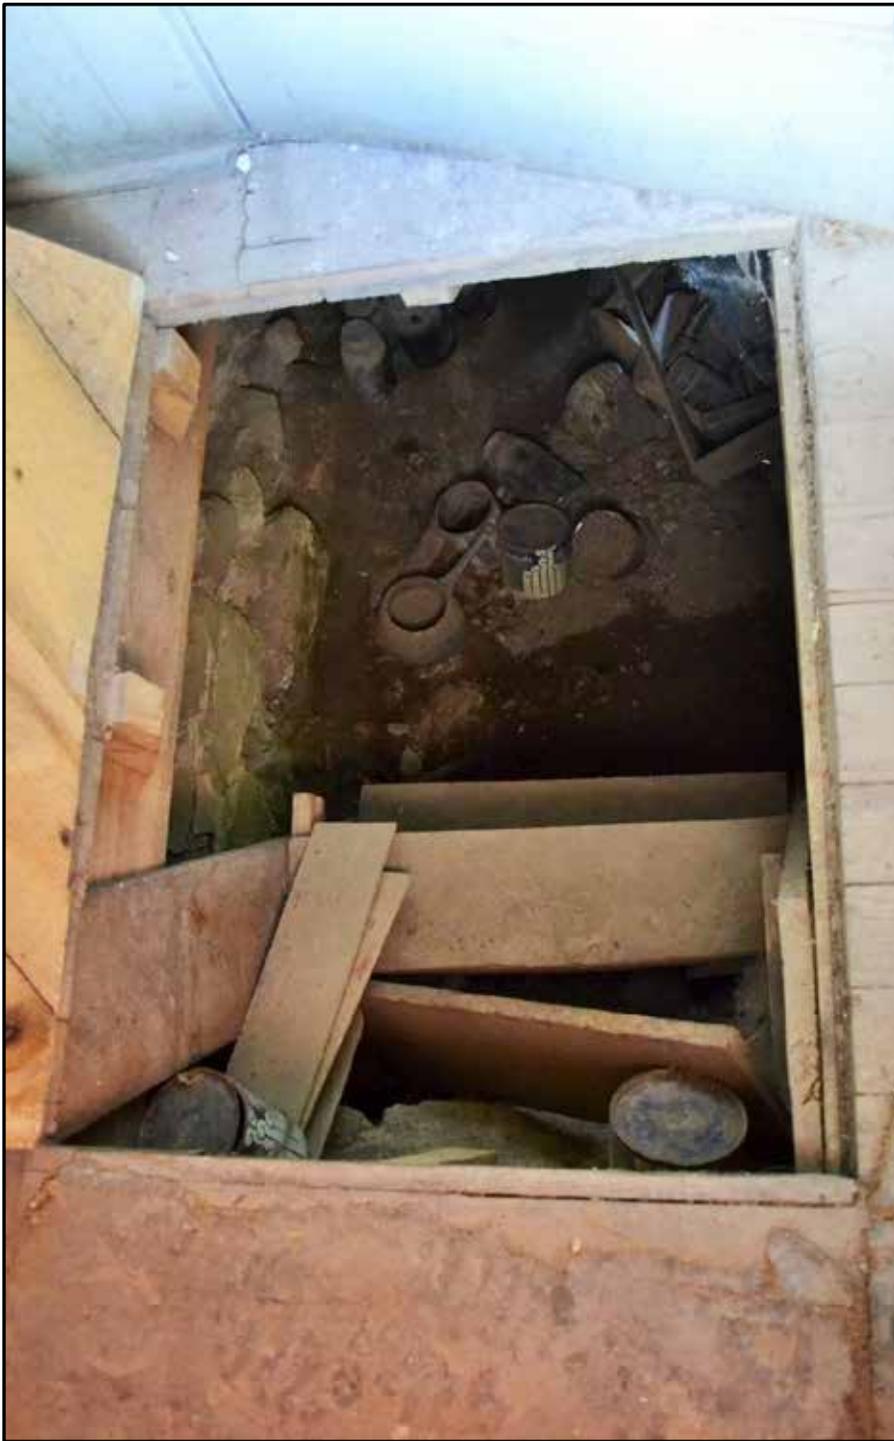
Figure 34. 1890s Farmhouse, first floor: Pantry (#3 on Figure 3) hatch open, allowing access to cellar/crawlspace below; view to the east.

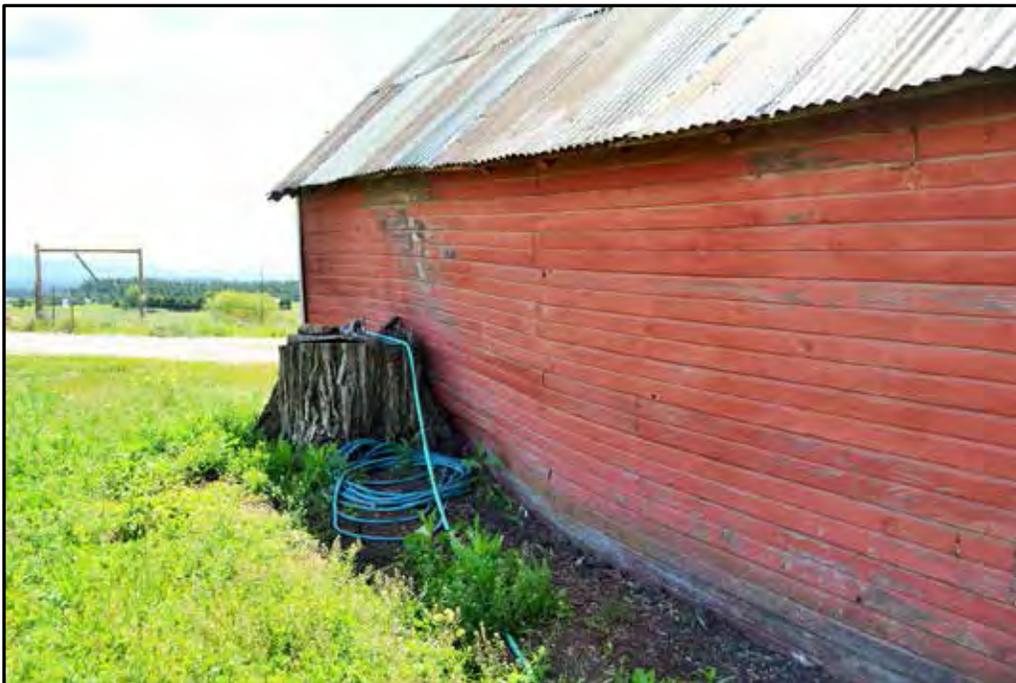
Figure 59. Garage, bowing of north wall due to growth of cottonwood tree; view to the southeast.

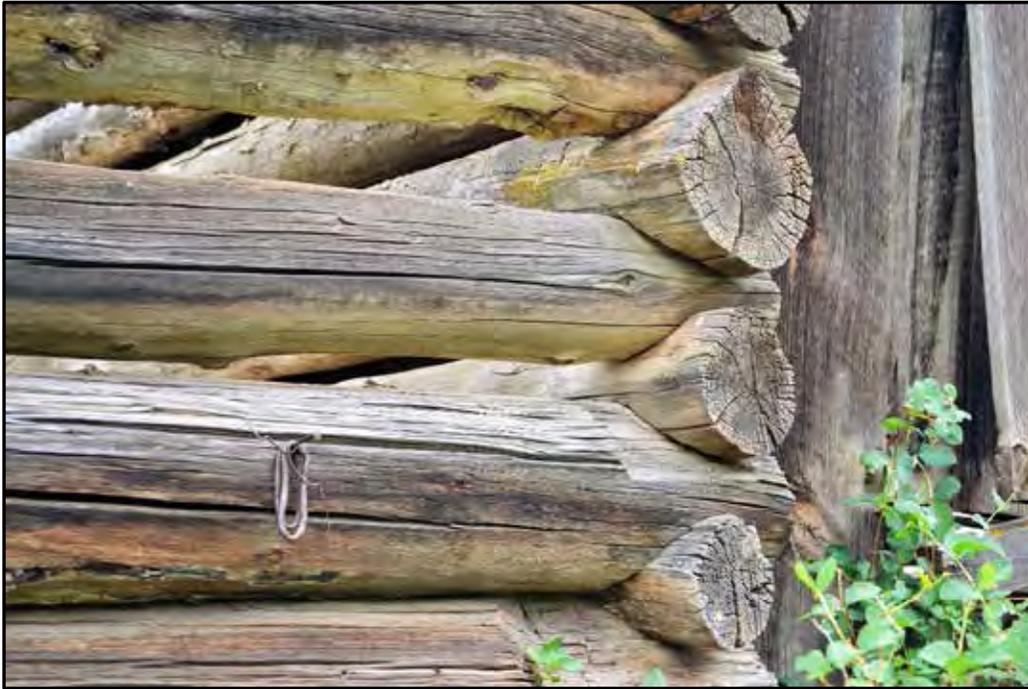
Figure 74. Barn, detail of corner notching at southwest corner of log section; view to the southeast.

Barn: The V-notched log barn was built between 1887, when the Trolans first settled on their homestead, and May of 1894, when a log barn of the same dimensions was noted on the Trolan homestead in the land entry file (General Land Office [GLO] 1887; Spokane Falls Land Office 1894). V-notched log construction is believed to have been introduced to North America in the 1730s by the Schwenkfelders, a religious group who emigrated to Pennsylvania from the German province of Silesia. V-notches were designed to shed water and, as American settlement expanded westward, this practical design spread into localized areas of the Midwestern and Western states (Glover 1982:171; Rock 1979:8, 9). By the late nineteenth and early twentieth centuries, during Euro-American settlement of northeastern Washington, V-notching was the most popular type of log construction in the region. Construction of the Trolan log barn in this regionally popular style is probably evidence that local residents assisted the newly-arrived homesteaders with construction of their first buildings.

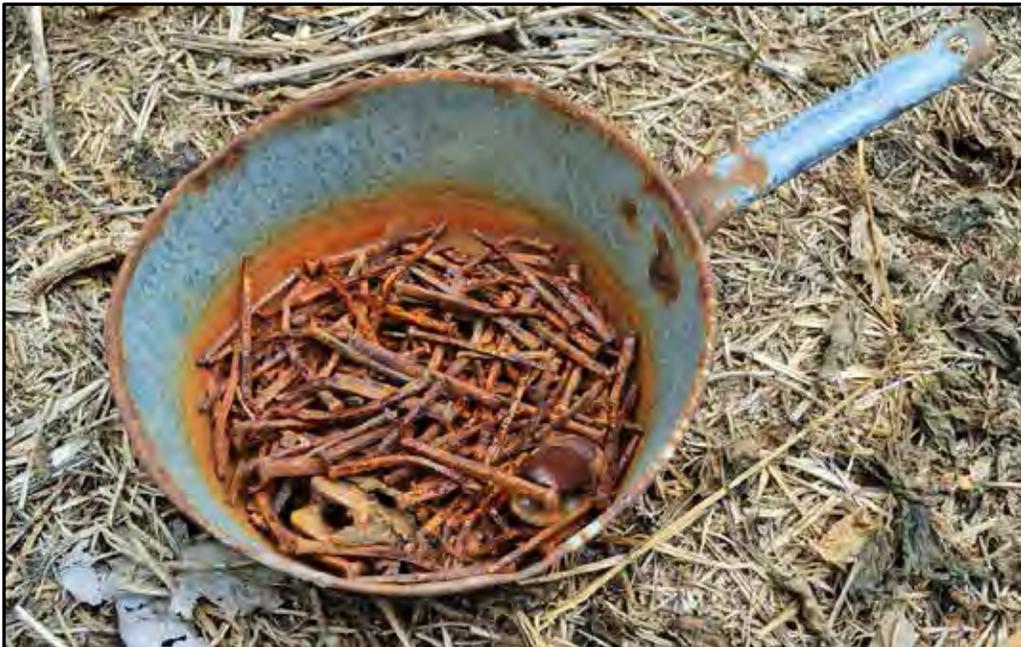
Figure 75. Barn: enamelware pan of corroded cut (square) nails in original log section; view to the northeast.

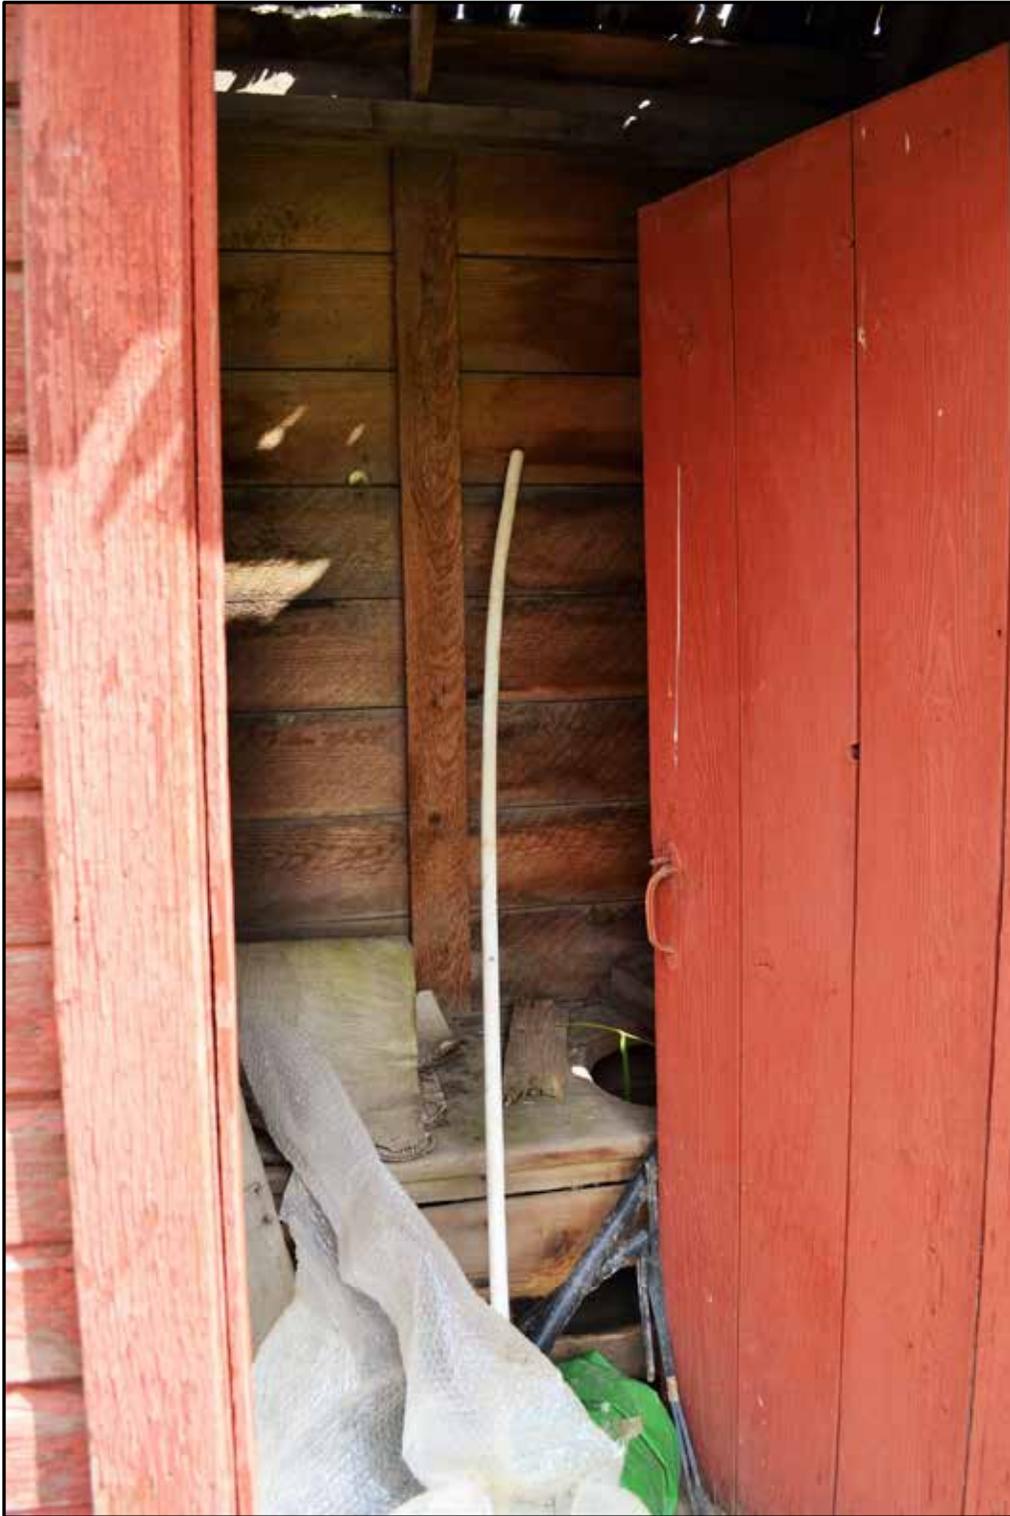
Figure 82. Outhouse, door and interior.

This small one-story side-gabled wood frame building, a simple rectangle in plan, is 5.5 feet wide and 4 feet deep (Figures 78 to 82). The building has recently been moved and now sits at an angle, facing northwest, near the northwest corner of the barn. The outhouse, painted barn red (the paint now flaking and weathered), rests on the ground, rather than on a foundation. Cladding is horizontal 4-inch wide simple drop siding boards with vertical corner boards. The roof is moderately pitched with moderately overhanging open eaves and exposed 1.5-inch x 2.5-inch rafter ends cut at an angle. Sheathing is 8-inch wide boards and roofing is corrugated sheet metal, installed over earlier wood shingles. The door, hand-crafted of vertical boards with a metal latch and handle, is placed off-center on the building face. The interior has a plank floor and a plank bench with two rounded-edge oval holes cut into it. All nails are wire and all lumber is

commercially sawed and less than full dimension. The outhouse is currently non-functional as there is no pit.

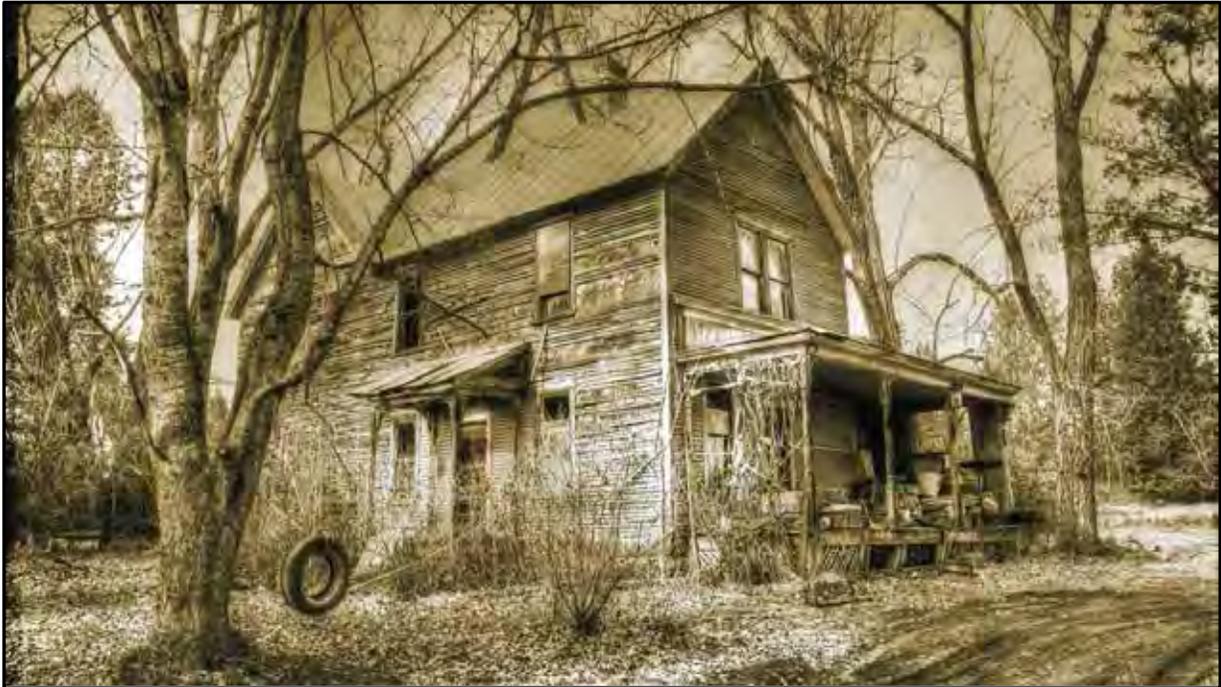
Figure 98. Trolan homestead (Trolan-Ellsworth) house, ca. 2014, prior to removal of the south side porch, chimneys, and a number of trees (photograph by Kristy Brown, courtesy of Connie and James Long).

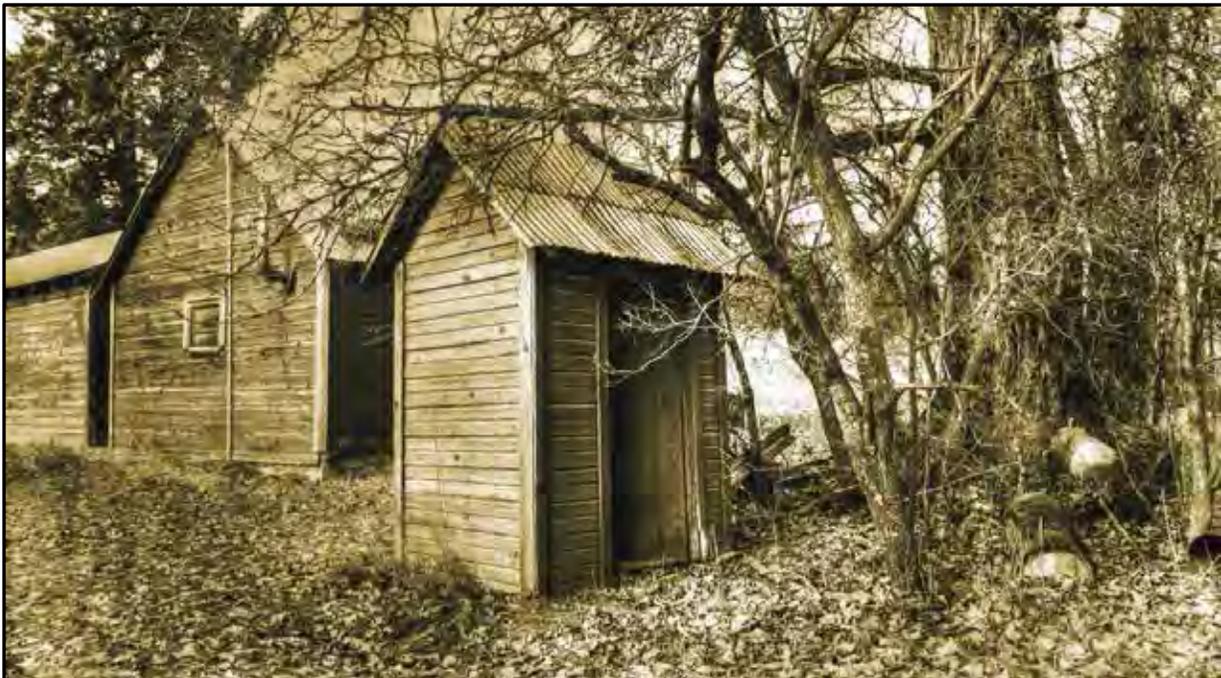
Figure 99. Outhouse, ca. 2014 prior to its relocation, just southwest of Trolan homestead (Trolan-Ellsworth) house (photograph by Kristy Brown, courtesy of Connie and James Long).
