Spokane Register of Historic Places Nomination

| 1. Name of Property | | | | | |
|--|--|---|--|---|--|
| | e: Arden Hotel non Name: Spokane N | Masonic Center | | | |
| City, State, Zi | ber: 506 W. Second A p Code: Spokane, WA r: 35191.2718 | | | | |

SUMMARY STATEMENT

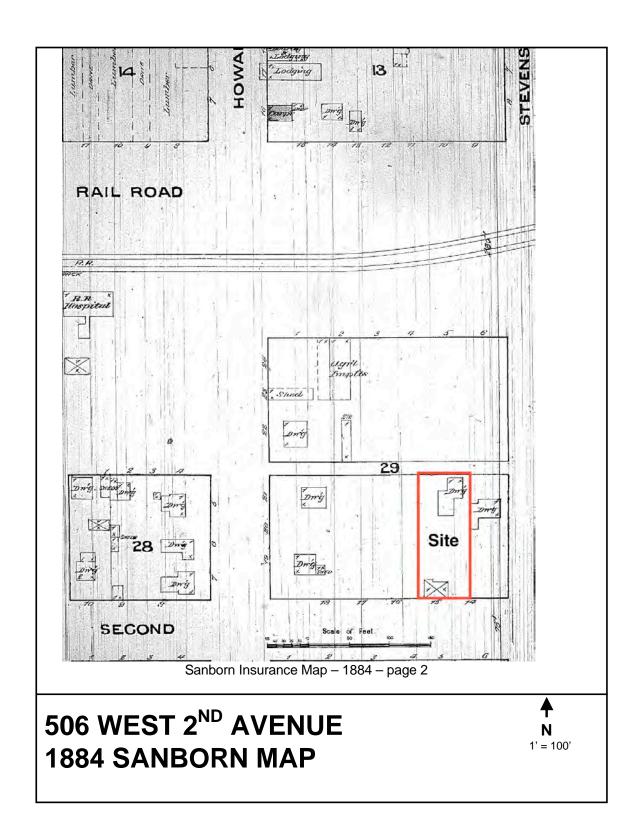
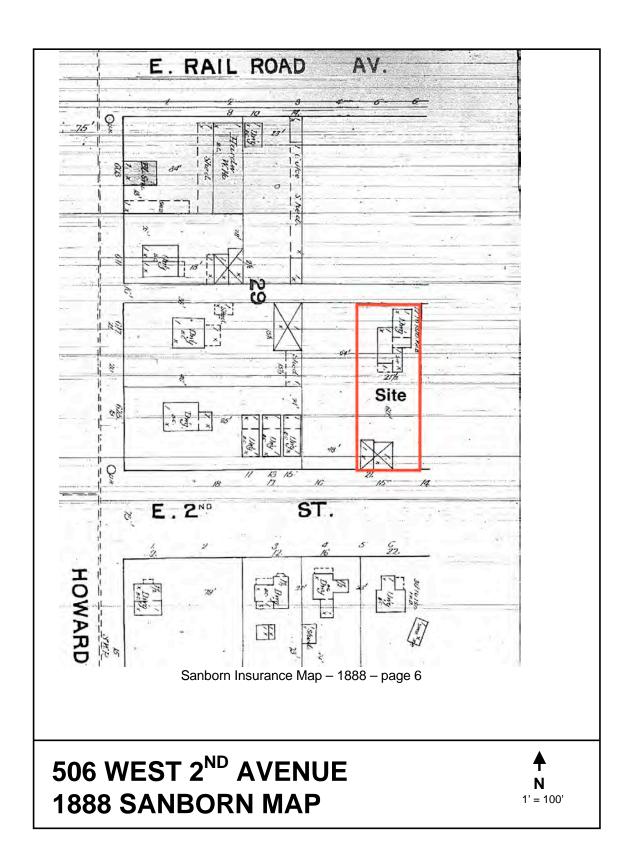
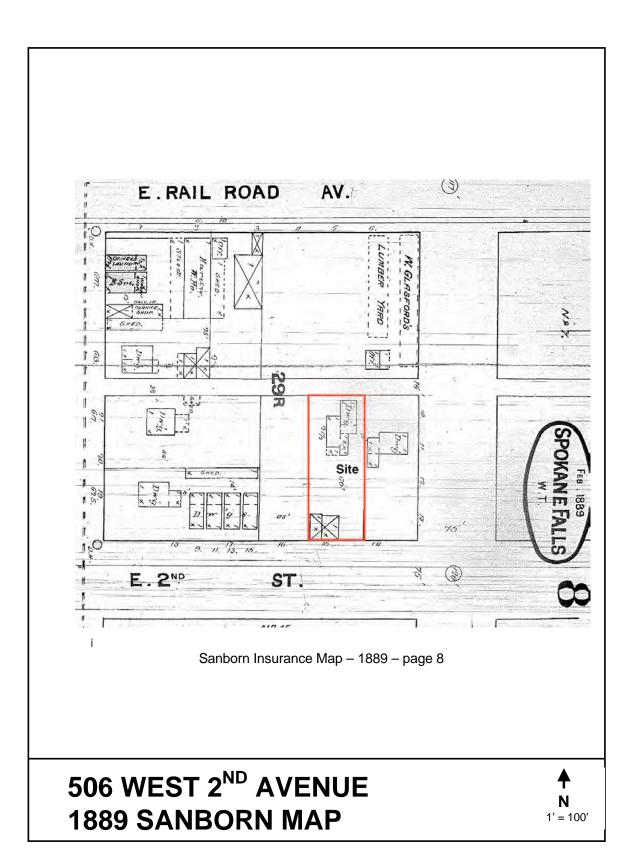
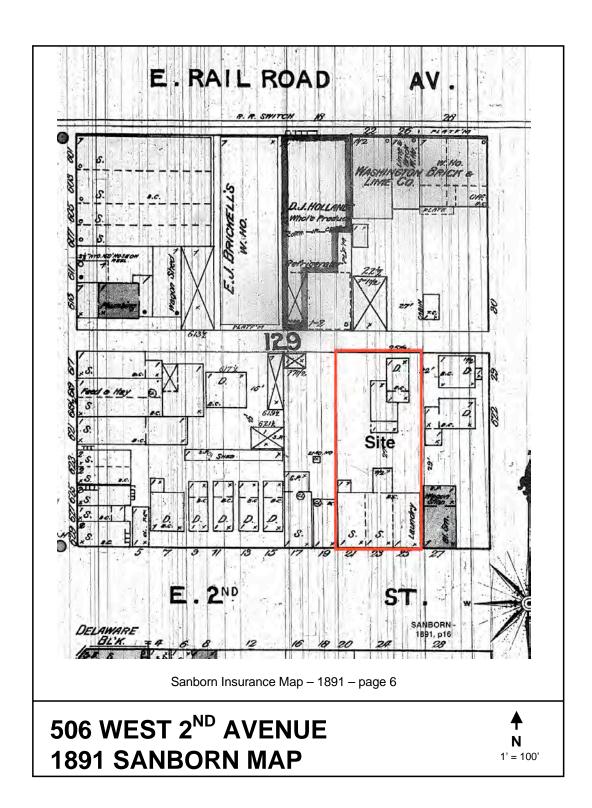
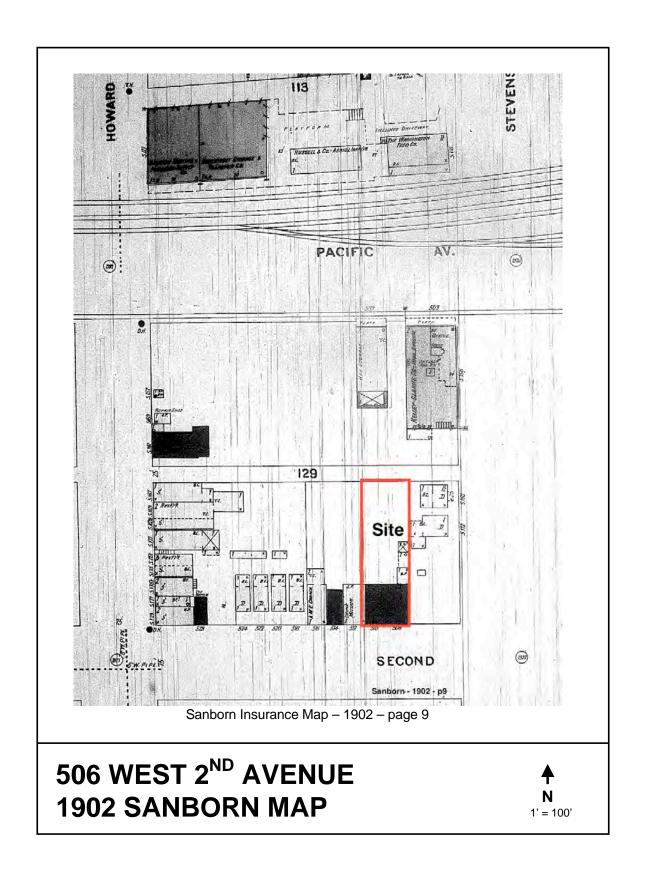
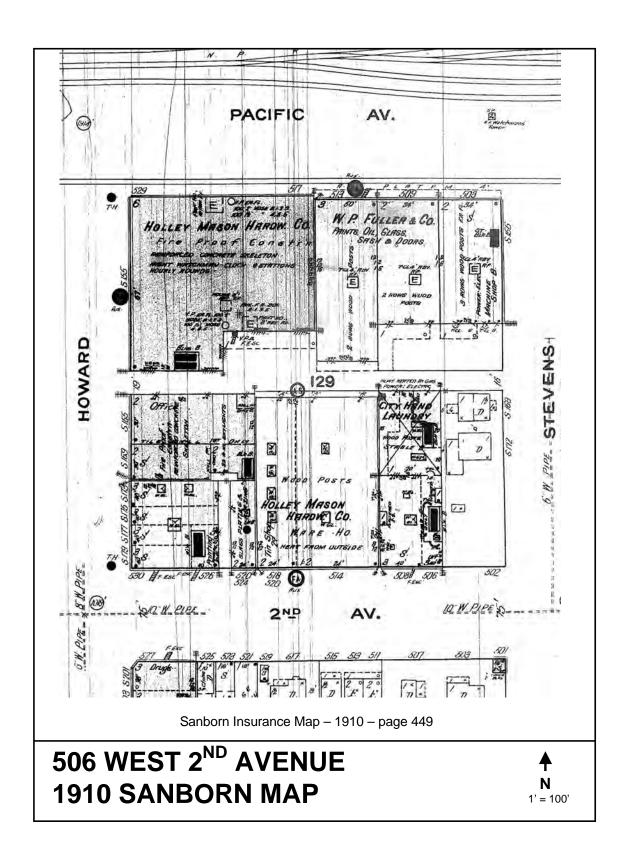
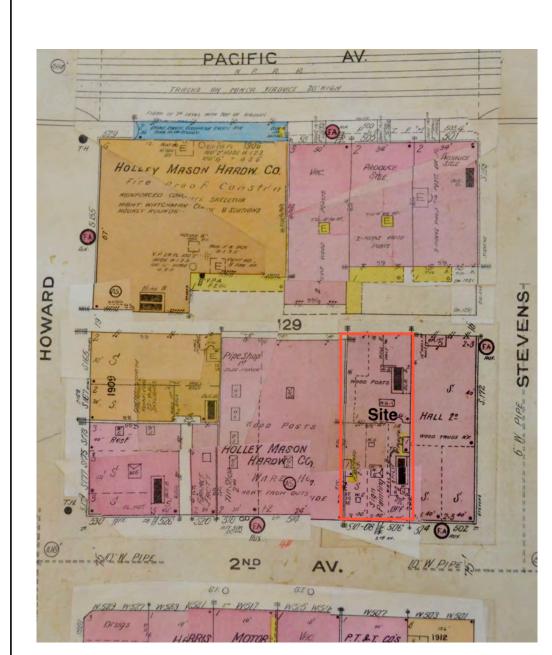
506 WEST 2ND AVENUE 1910 SANBORN TO 1928

Sanborn Insurance Map - 1910 updated to 1925- page 449

The first map depicting the site of the Arden Hotel was the 1884 Sanborn Fire Insurance Map. Stevens bounded the east side of the block, Second Avenue, the south, Howard, the west, and the Northern Pacific Railroad, the north. The site was occupied by a wood frame dwelling on the alley and a wood frame shed along Second. The remainder of the southern half of the block had three dwellings, including one adjacent to the east. A dwelling, a shed, and a shop denoted as Agricultural Implements (all wood-frame) were on the north half of the block across from the Northern Pacific Railroad tracks. The block to the west had wood frame dwellings and a R. R. Hospital.

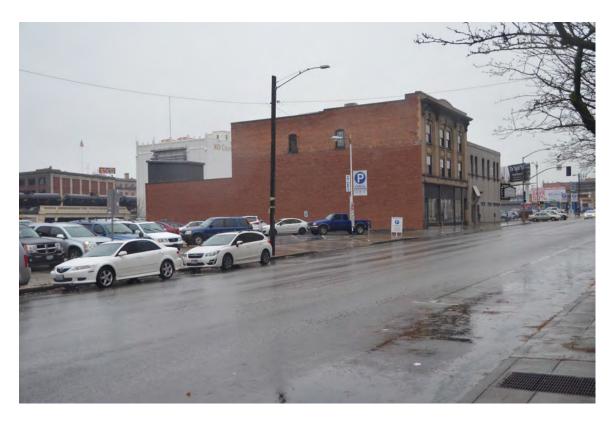
1. Context along 2nd Street, looking NE

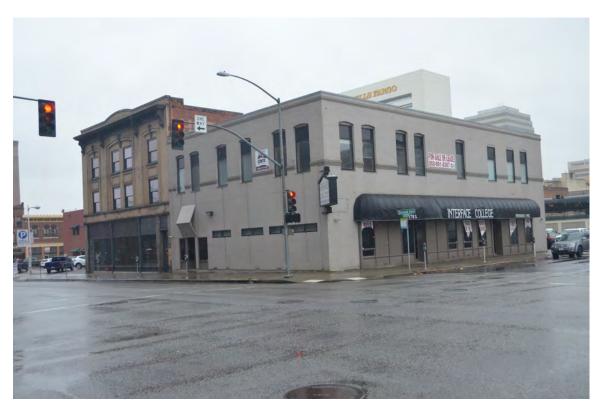
2. Context along 2nd Street, looking NW

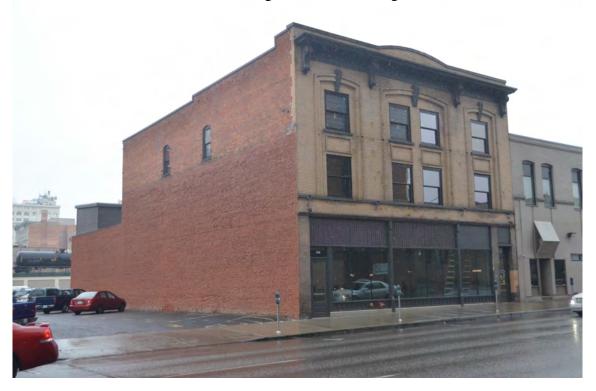
3. Southwest Corner, looking NE

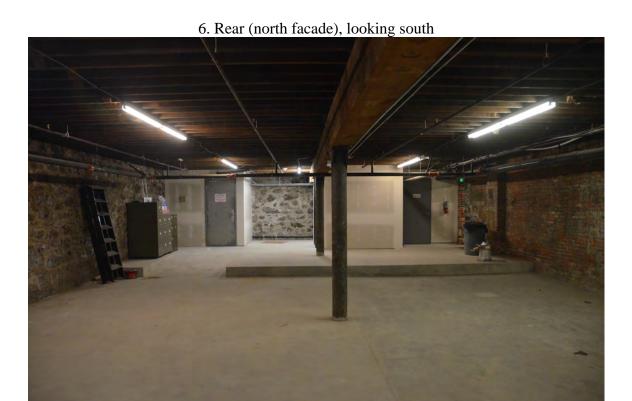
7. Basement-main room in south section, looking north toward elevator

The basement consists of basalt rubble, concrete, brick and cement block walls, concrete floor and exposed joists. The basement is divided into two main sections by a basalt rubble wall. The larger space is the front (south), generally coinciding with the three-story section, and is divided length-wise into two rooms. The narrower room, along the east side is about 1/3 the width of the basement. The larger room includes a new stairwell to the main floor near the south end, and a new elevator shaft and equipment rooms against the north wall. Round iron posts support 12" x 14" wood beams that run along the center of the larger room. The northern portion of the basement, beneath the one story section, is divided into two rooms with a staircase to the main floor in the northwest corner. Wood post and beams provide structural support. Walls are basalt rubble and concrete block with poured concrete forming the north wall. The basement includes utilities and storage spaces.

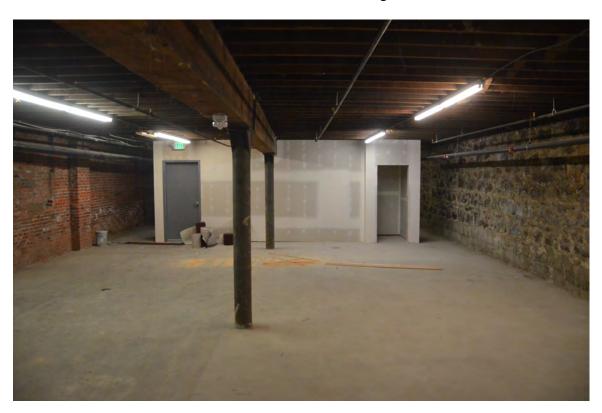
8. Basement-main section, looking south

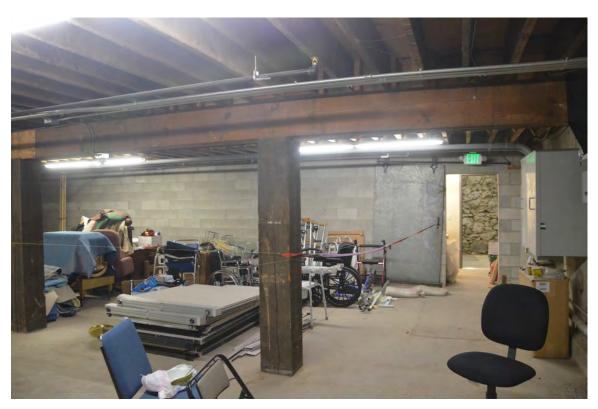
10. Basement-north section, looking west

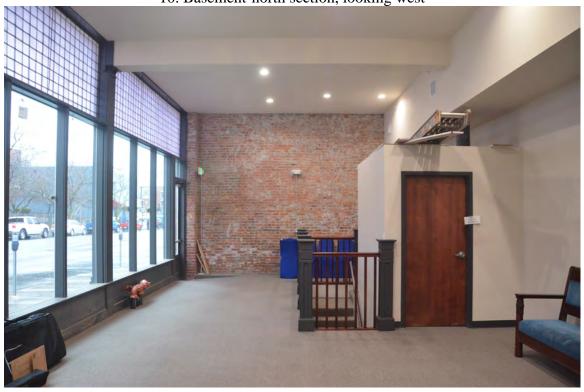
11. First Floor front Lobby showing stairs to basement and entry to Lodge Hall, looking west.

The first floor has been completely altered with the removal of the original store bay partitions. The space has high 14-foot ceilings and is divided into four basic sections, from front to back (as opposed to side to side as in a traditional multi-tenant commercial building) in its adaptation to the Masonic Lodge building. The front consists of a vestibule that runs the width of the building (except the original stairwell along the east side). Near the west end is a new open stairwell that provides access to the basement. Within the center core is the Masonic Temple meeting hall. A corridor along the west wall provides access to an open room with elevator shaft, a men's restroom, a women's restroom, and a janitor's closet. An arched opening in the exposed brick wall provides access from the north end of the three-story building section to the one-story wing at the north end. Within the open room that extends across the width of the north section is a utility room (with powder—coated metal panels on the walls) on the east side, an open room in the middle, and an enclosed stairwell in the northwest corner. The stairwell provides access to the basement and to a penthouse on the roof. The walls and ceilings are plaster, with some exterior walls of exposed brick. The floors are generally carpeted.

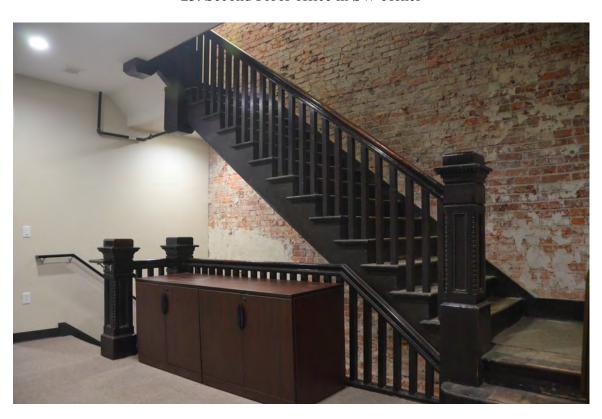
26. Second Floor original stairway between 1st and 3rd floors, looking east

In the southeast corner (front) of the building is an original door opening that provided access to the second and third floor apartments (now offices). Accessed by the door is a small foyer and stairwell along the east wall. To the north, the original wooden stairs ascend in a straight run, with intermediate landing, to the second floor landing, then with a left turn, and two steps to the second floor. The original newel posts, railings, and square wood pickets remain intact.

The original east stairs have been refurbished and run from the second to the third floor. The third floor is planned to be completed but is currently unfinished with the exposed original wood studs. In the northwest corner room is the elevator, and a step access through corner window to access the roof.
