<p>Washington State HERITAGE BARN REGISTER</p>	Farm Name Hengen Farms LLC	Property Location Address: E 3508 Spangle-Waverly Road City: Spangle, WA Zip: 99031
	Historic Name Clark, George, Barn	County Spokane
	Owners Name Nona Hengen Phone: (509) 245-3366 Email: nhengen@centurytel.net	Owner Address Address: E 3508 Spangle-Waverly Road City: Spangle State: WA Zip: 99031

HENGEN BARN

a timber frame barn

built in 1900

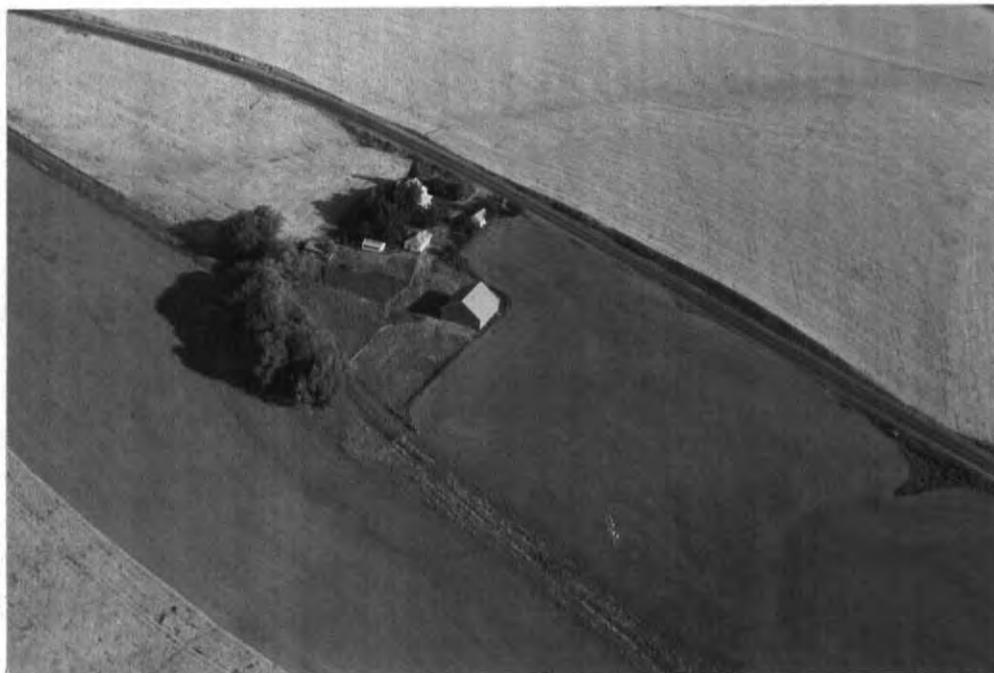
1974 Photo

A schematic of the farm in the decade after WWII. The "building activity" on this 1884 homestead probably reached its heyday in the Victorian era after rail transportation (1886) reached the town of Spangle and farm machinery could be brought in and wheat shipped out. (First track laid through Spangle was in 1886).

On the next two pages are separate drawings I made (one in 1946, when I had turned 12, the other a year later, I believe) when I hiked with a tablet and pencil to the "big hill" south of our buildings to make a drawing of the farm.

The view is toward the north. These are the buildings as I remember them now, looking at these drawings and recalling childhood memories. It was around the end of WWII war, that the maintenance of all these structures had become a problem and my grandfather and father began to tear down those where use could be consolidated into a more stable standing structure. The buildings that were standing in 1946 were:

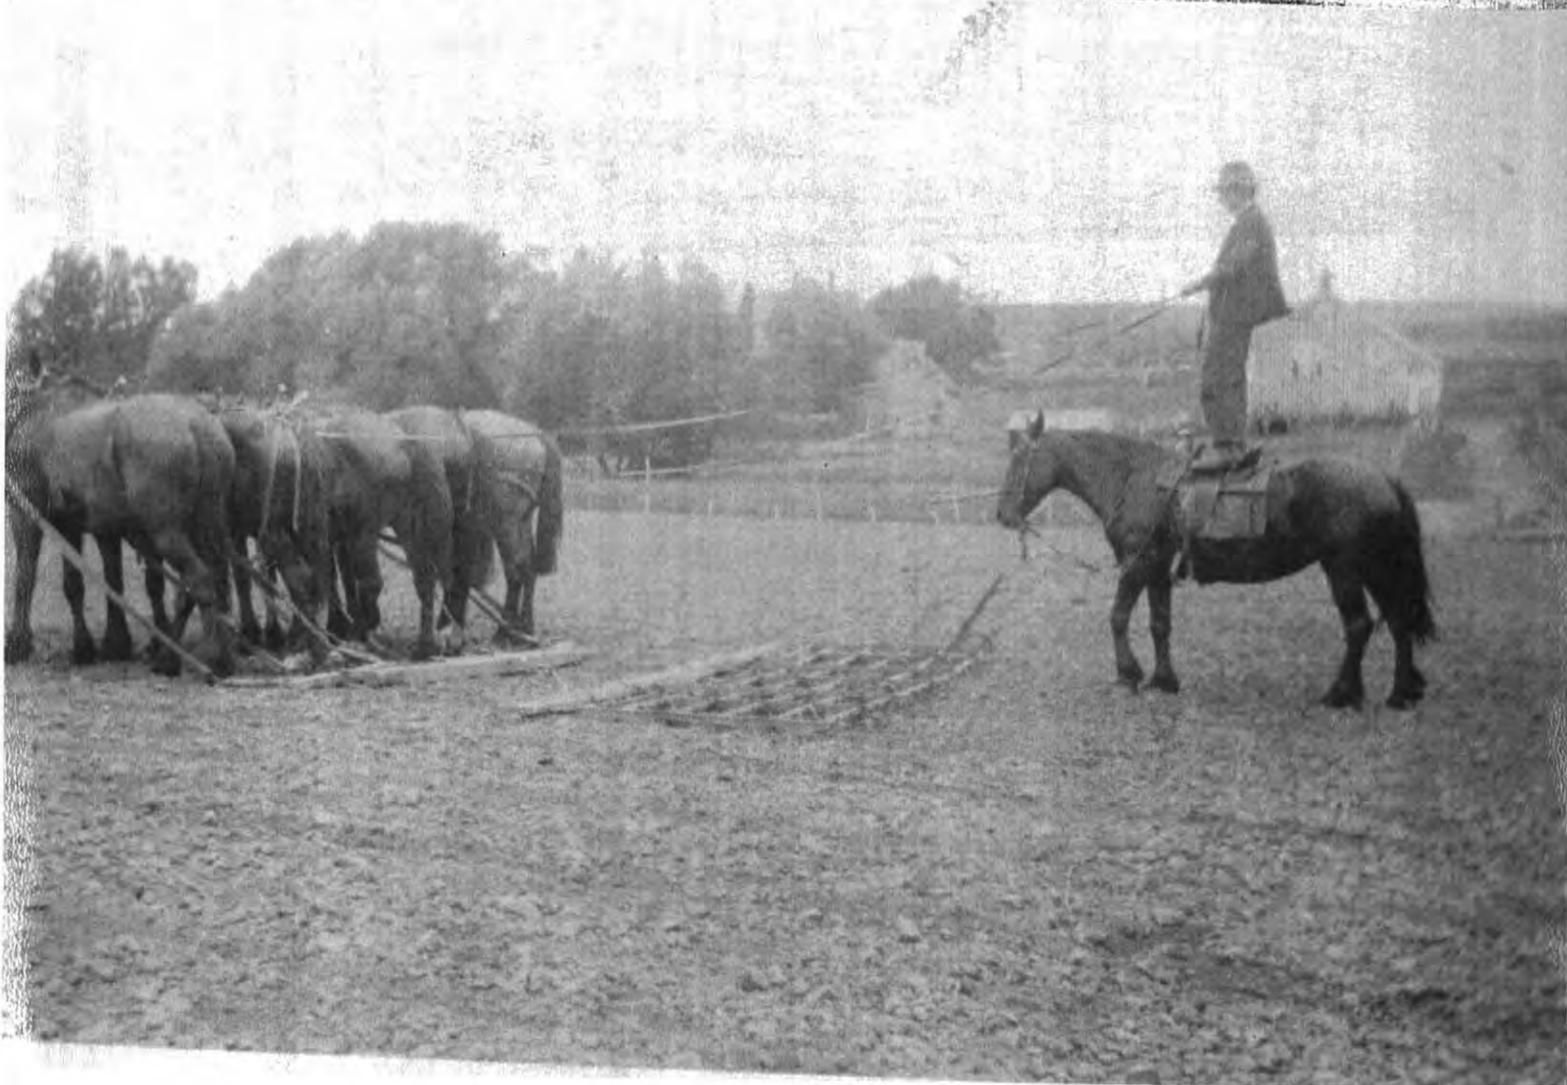
This is the earliest known photograph of the "Old Clark Place," taken by Libby Photographers, Spokane, in 1909. The house is one year old; to the right, the ridgepole and cupola of the barn may be seen. The barn was built in 1900, with lightning rods along the top. In 2008, my family will have lived on and owned this farm for 95 years.

In the foreground is the old "Dashiell Road," today known as the Spangle-Waverly Road connecting small towns in southeast Spokane County.

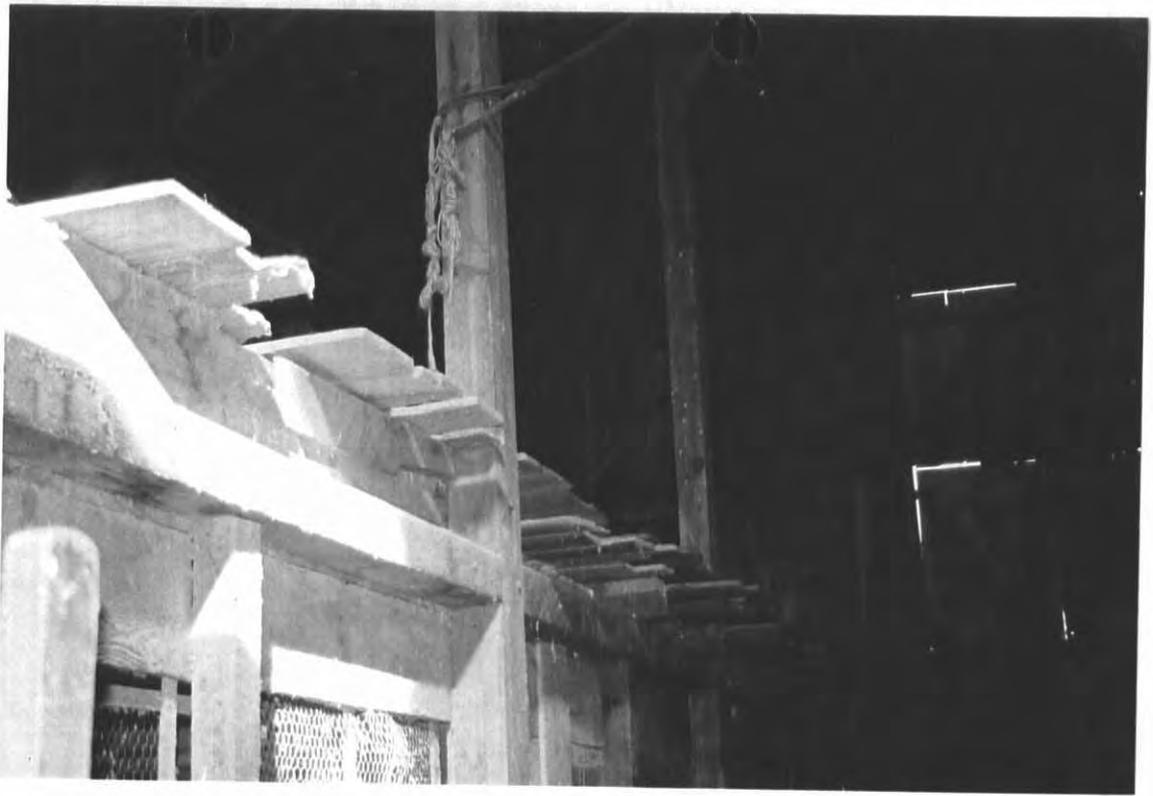
The barn has two "leans" where wheat bundles (green, cut with a binder in early June just before ripening) were stored for the horses' winter forage. Note the boards cut to uneven lengths here also. For the most part, these boards do not appear to be "nailed down" but are laid side by side, anchored at either end.

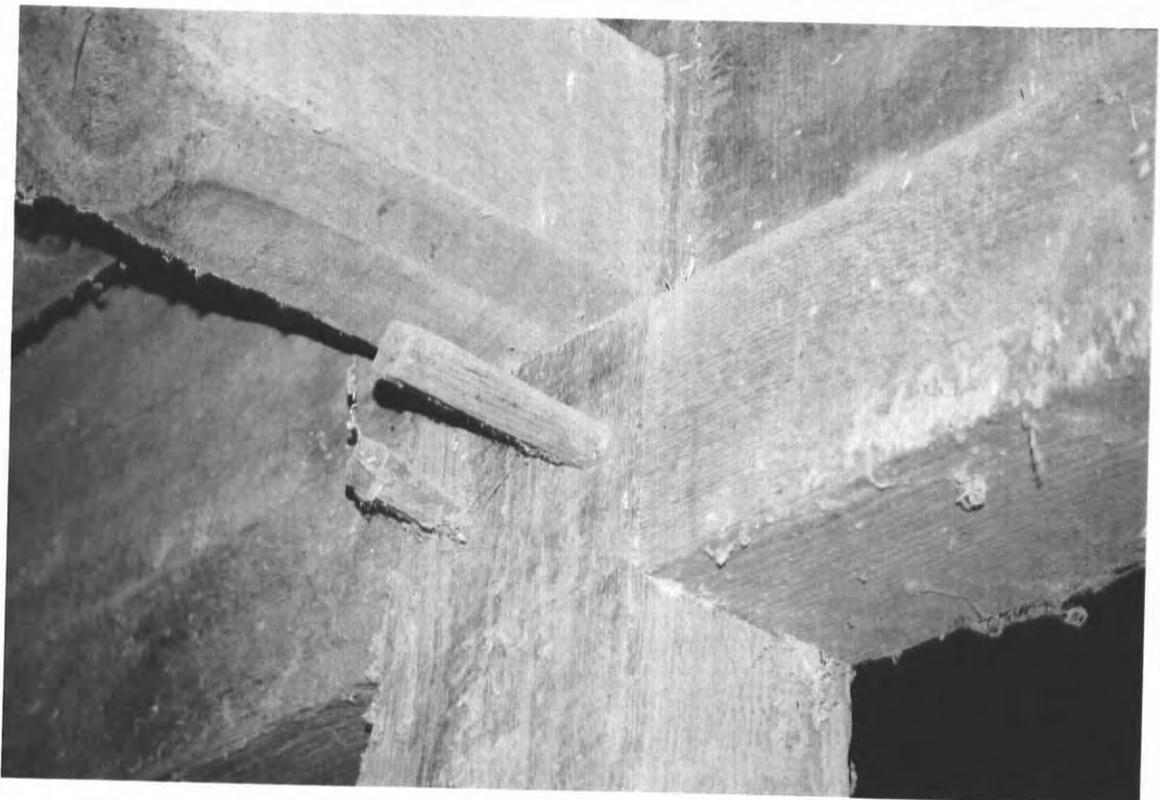
Detail of wood pegs or spikes used to hold the main beams of the barn in place. The joining shown is between ceiling of first floor and lean floor above.

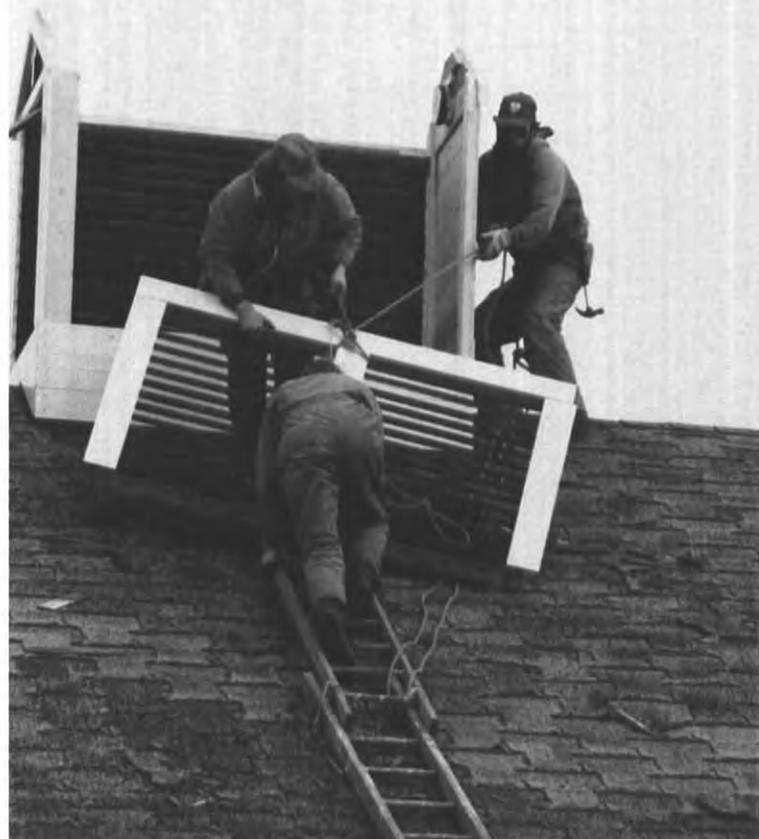
I wanted to give the barn the look it had had when it was constructed in 1900, and that meant putting a cupola back on top of it. A photo in the family album, taken in 1914, showed that original cupola, and the spiral lightning rods which also ran the length of the ridgepole.

The lightning rods were removed sometime in the 1920s, thought to be more decorative than useful, and a nuisance to maintain in an upright position up on the roof.

The young men shown here (neighbors) were curious as to why the barn had had a cupola in the first place.

I said, "ventilation. It was important to cure hay in the fields, and bring it to the barn absolutely dry. If there was any question about that, hay was "salted" when each hay wagon load had been pitched into the barn.

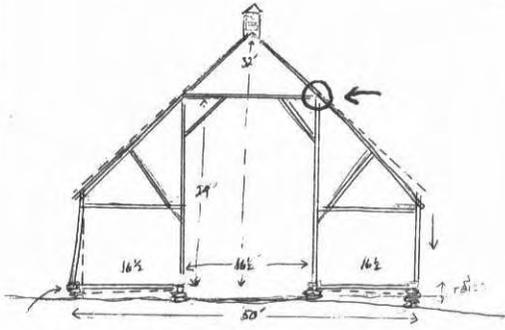
The tenon-mortise connection between crossbeam and vertical beam has become tenuous, producing gaps of 1 to 3" in the major support beams. It is thought that the pegs driven in may have split the tenons, thereby negating their ability to hold the connection in place.

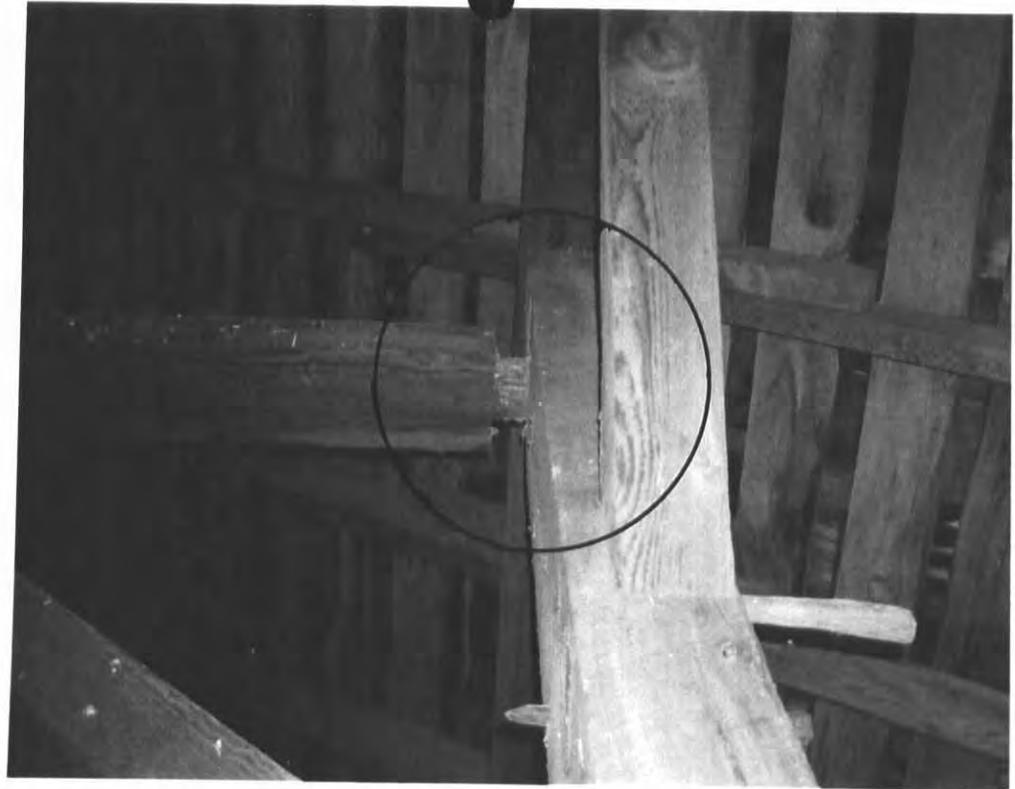
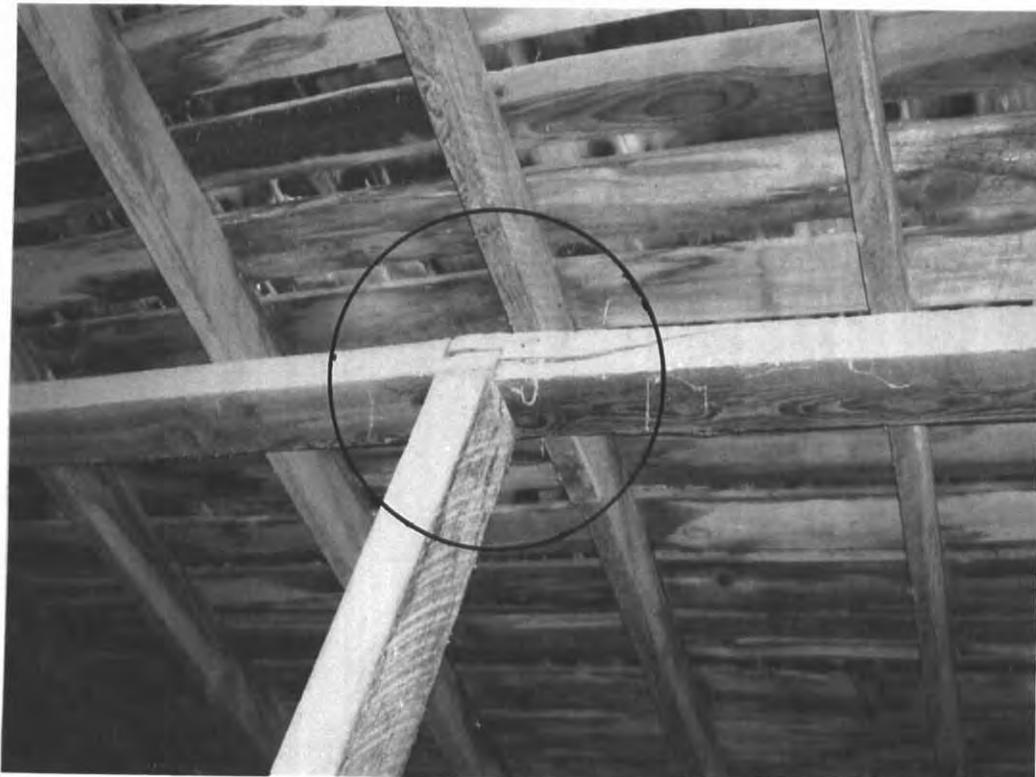
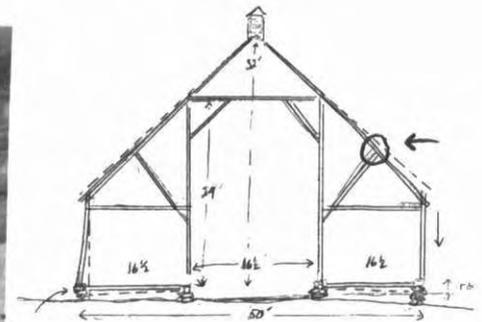
Cracking support rafters

Most of the pegged diagonal supports have not yielded to the weight of the roof by cracking, as this one has, but are showing stress.

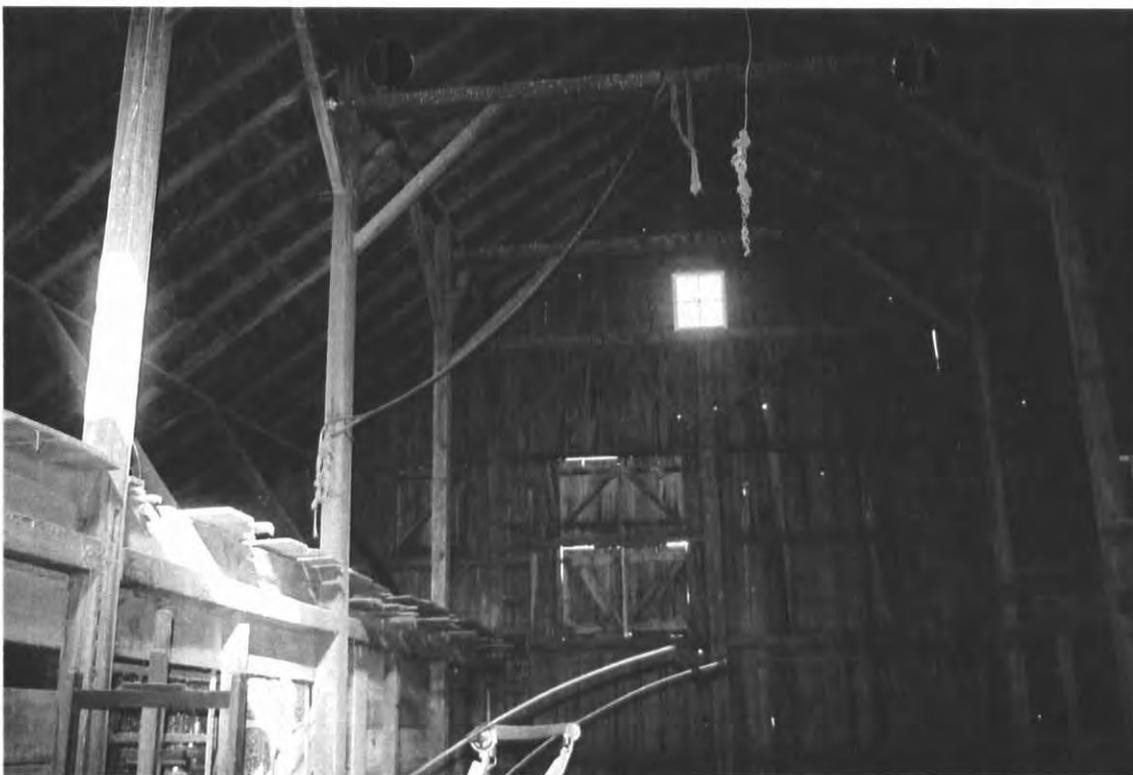
The view here is to the north, where the window at the apex, and the double doors below, left (where hay was forked in) are original to the barn's design. There has been no alteration to the north facade of the barn, which faces the Spangle-Waverly Road and is most photographed by passersby.

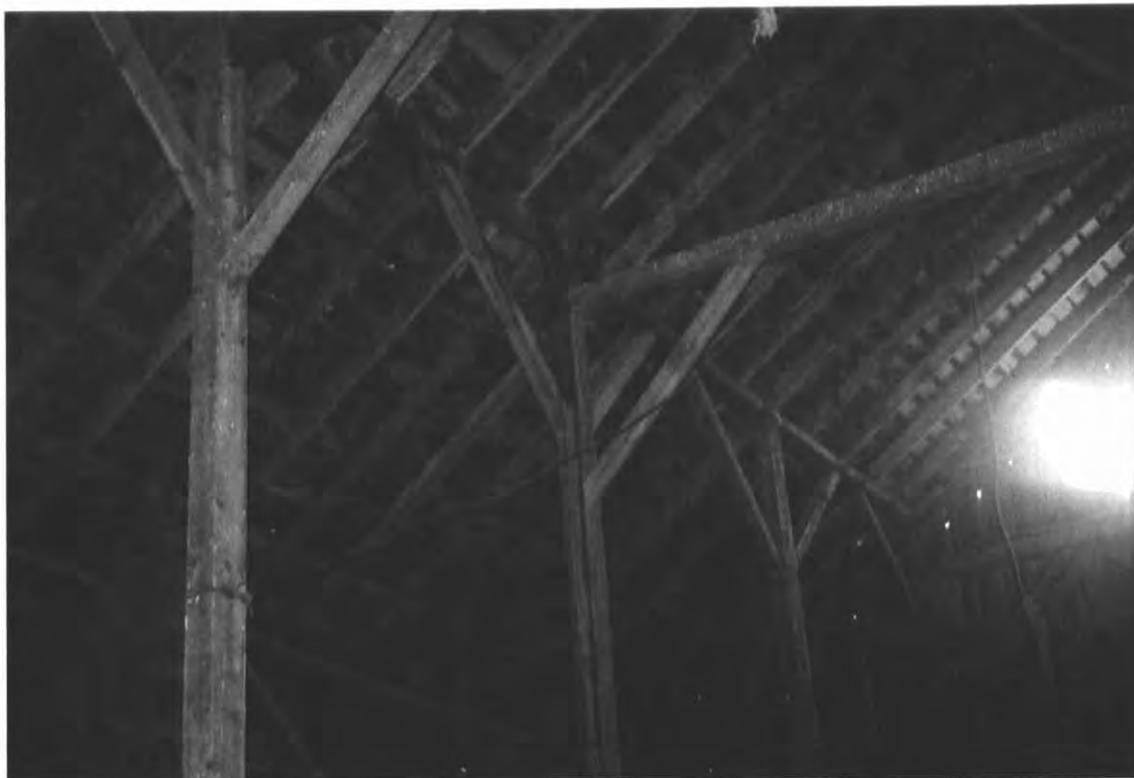
Looking to the southeast barn interior, note the missing cross beam (third one over from left). It apparently interfered with hanging a pulley over the beam next to it, with a rope and harpoon fork that could save work of pitching loose hay by lifting the load of hay off a wagon in one or two "swings."

Removal of the 4th straining beam in the 1940s to allow clearance for a pulley and harpoon fork device weakened the roof support. The uprights connected by that 4th beam have moved 8" on one side, 6" on the other.

Cabling will prevent further movement and hopefully turnbuckling can reduce that 14" spread, and a replacement beam can then be brought into place.

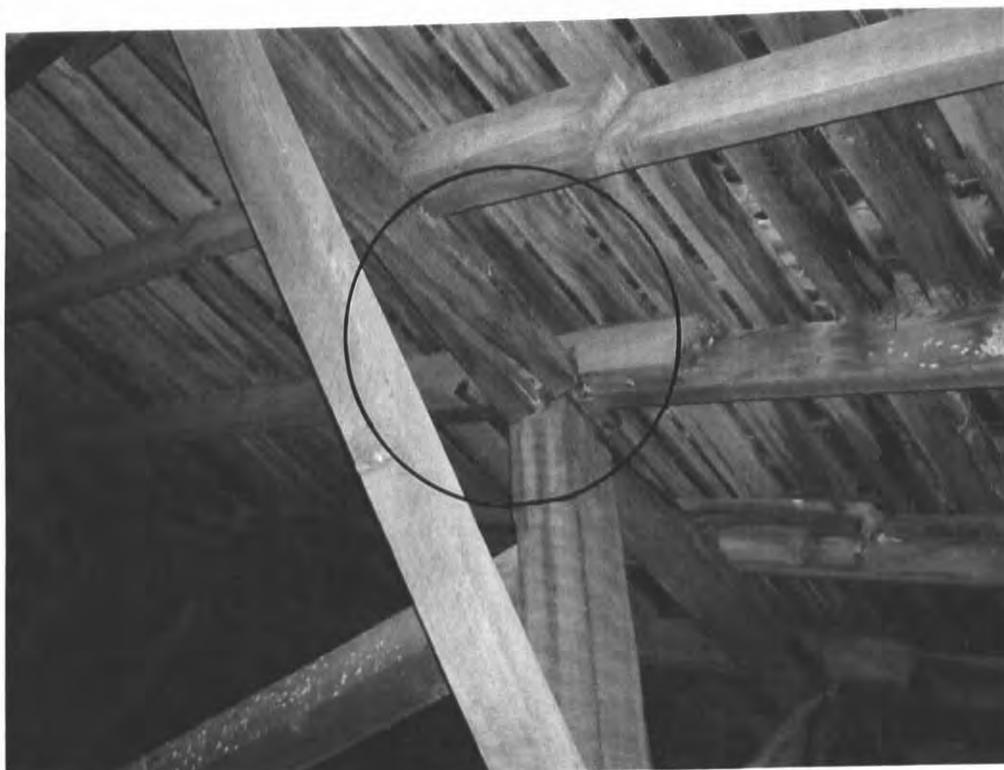
A horizontal timber (purlin) supporting the rafters has split and twisted.

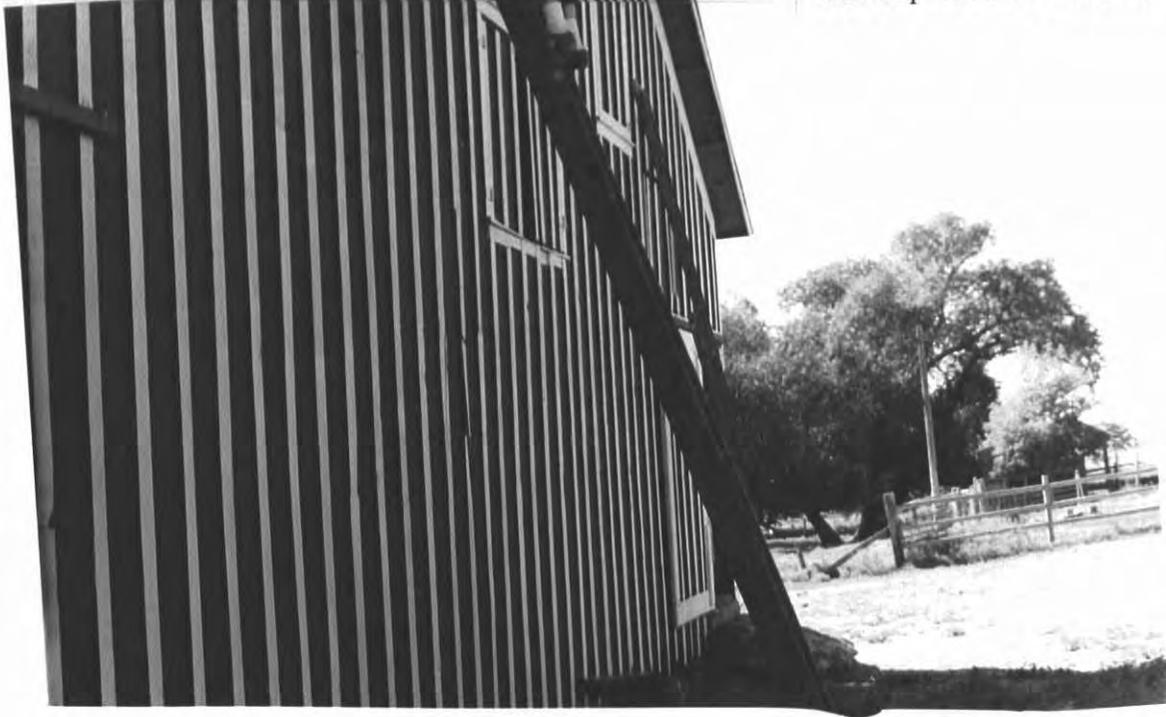
PAINTING THE BARN, 1977

My mother is on the ladder. We bought 5 five-gallon buckets of an off-red paint (the paint store advised us that the brightness of "barn paint" achieves that brightness with lead, which animals can lick off and become ill) and 2 five-gallon buckets of white paint for the battens. It took us a little over a week.

The back of the barn is tinned, and not visible from the road, so we painted only the three sides.

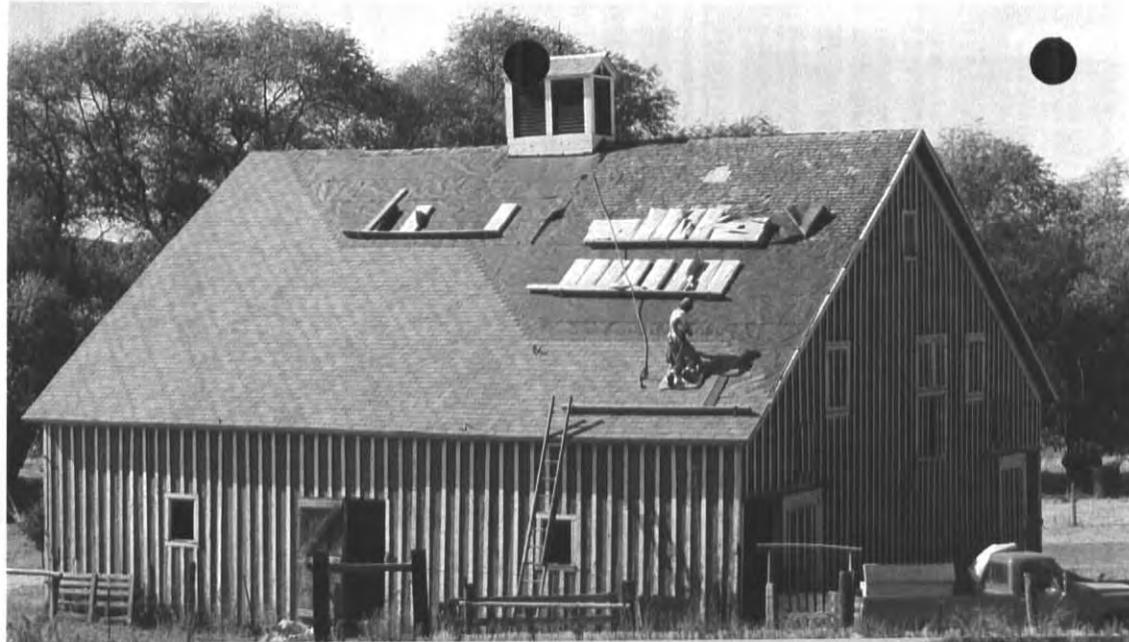
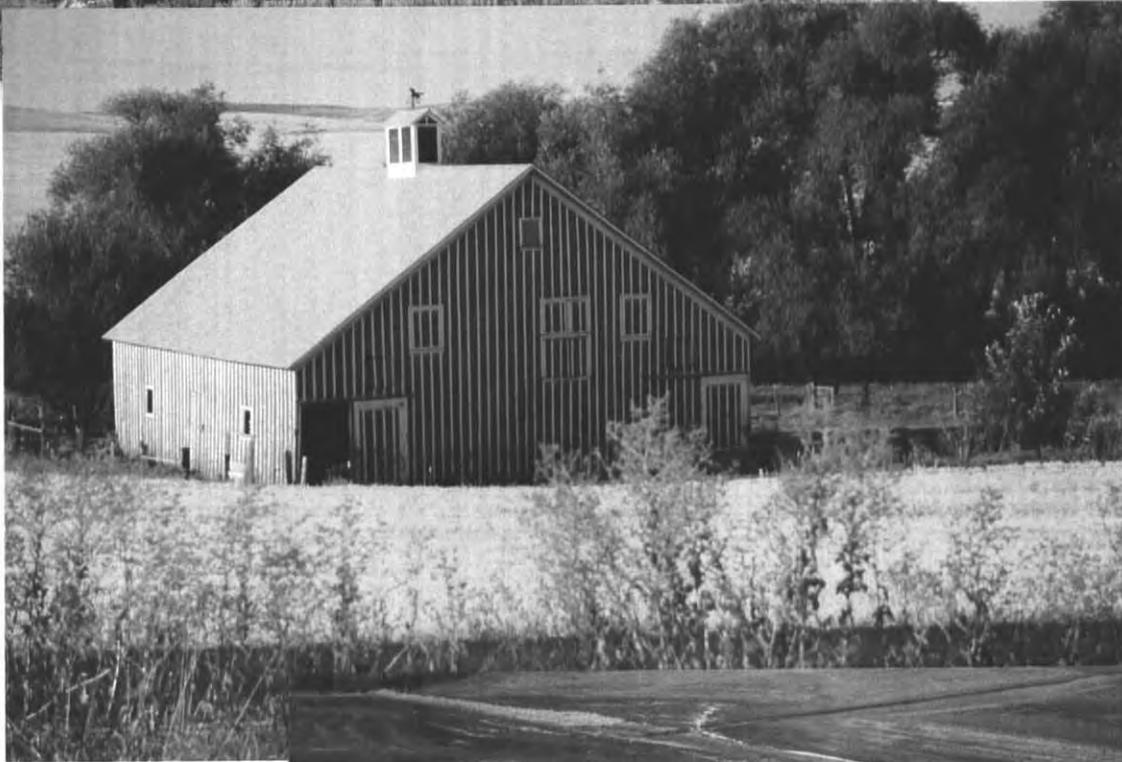
East side of the BARN 1994

Sometime in the 1970s, a T-lok roof was put on the barn.

With $\frac{1}{3}$ (33%) pitch and rise, the barn has 1800 square feet per side or 3600 square feet of net roofing area.

The roof put on in 1994 was guaranteed 25 years for material but only 5 years for wind damage. In 2007 a dozen or more shingles were torn off by the wind on the east side, and perhaps four times as many on the west side (prevailing SW winds).

Sept. 13, 1994, Inland Roofing of Spokane removed it, hauled off the debris, installed 15# felt on the roof and re-roofed with SG-25 by Pabis, with a 25 year guarantee. The material was hand-nailed. Cost to roof half of the barn, **\$2,946.67.**

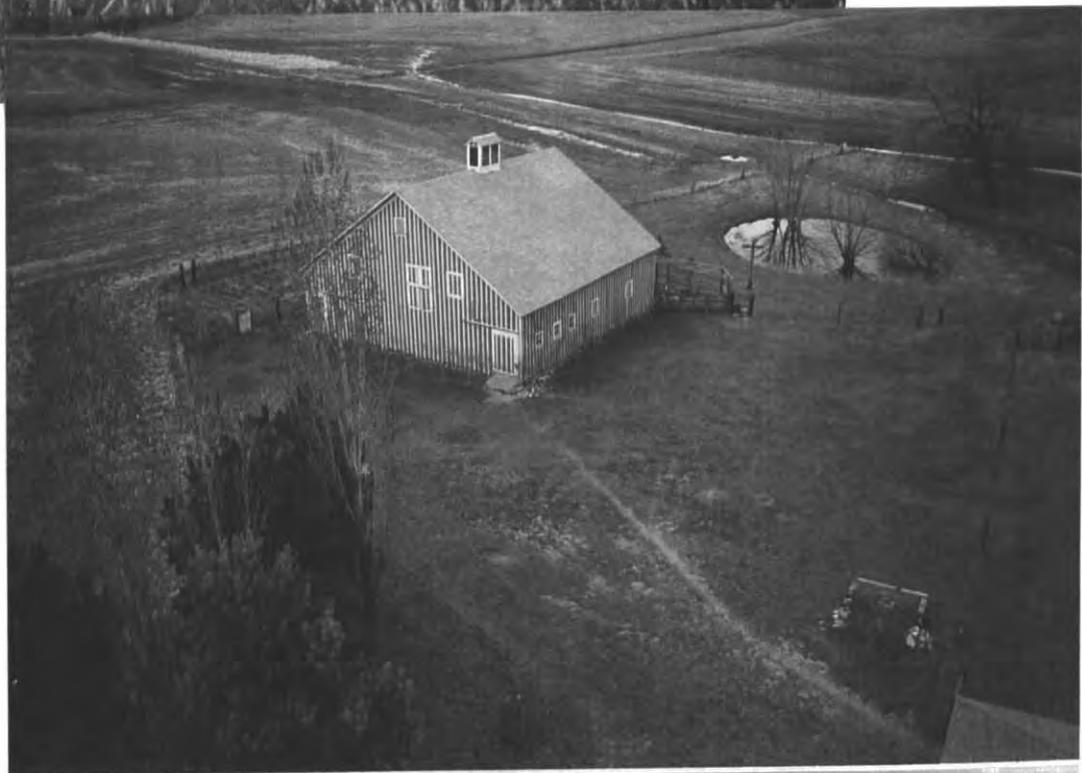
PAINTING THE BARN AGAIN-- in 2001

Adjoining my farm is the
Upper Columbia Academy
Seventh Day Adventist

boarding school. It dispatches teens four times a year to help out in the community. Here, a start is made on painting the barn, but because school insurance would not allow the high schoolers to climb over 6' on ladders or operate power tools, such as a pressure hose, this effort barely "got off the ground."

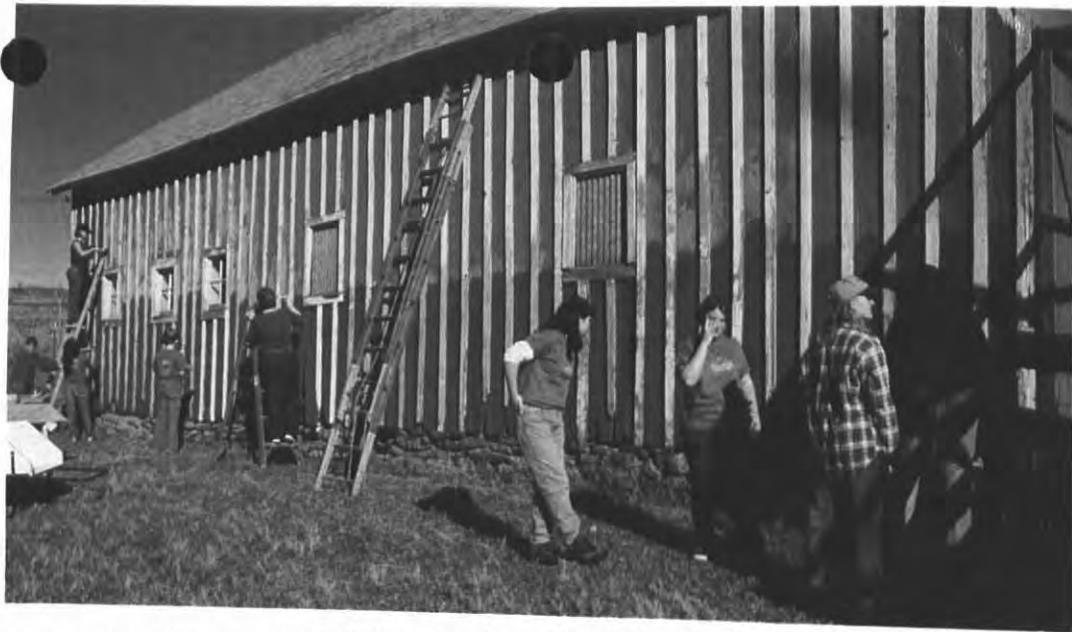
HIRING THE PAINTING PROFESSIONALLY DONE

In 2001, I hired Bailey Construction to paint the barn, as 24 years had elapsed since my mother and I painted it in 1977. All the old paint was pressure-hosed off, the boards were spray-painted red and the battens hand-painted white at a cost of \$2600. At this time, nine windows were replaced, new sills built, the cupola caulked, around, and shingles torn loose by the wind. were replaced.

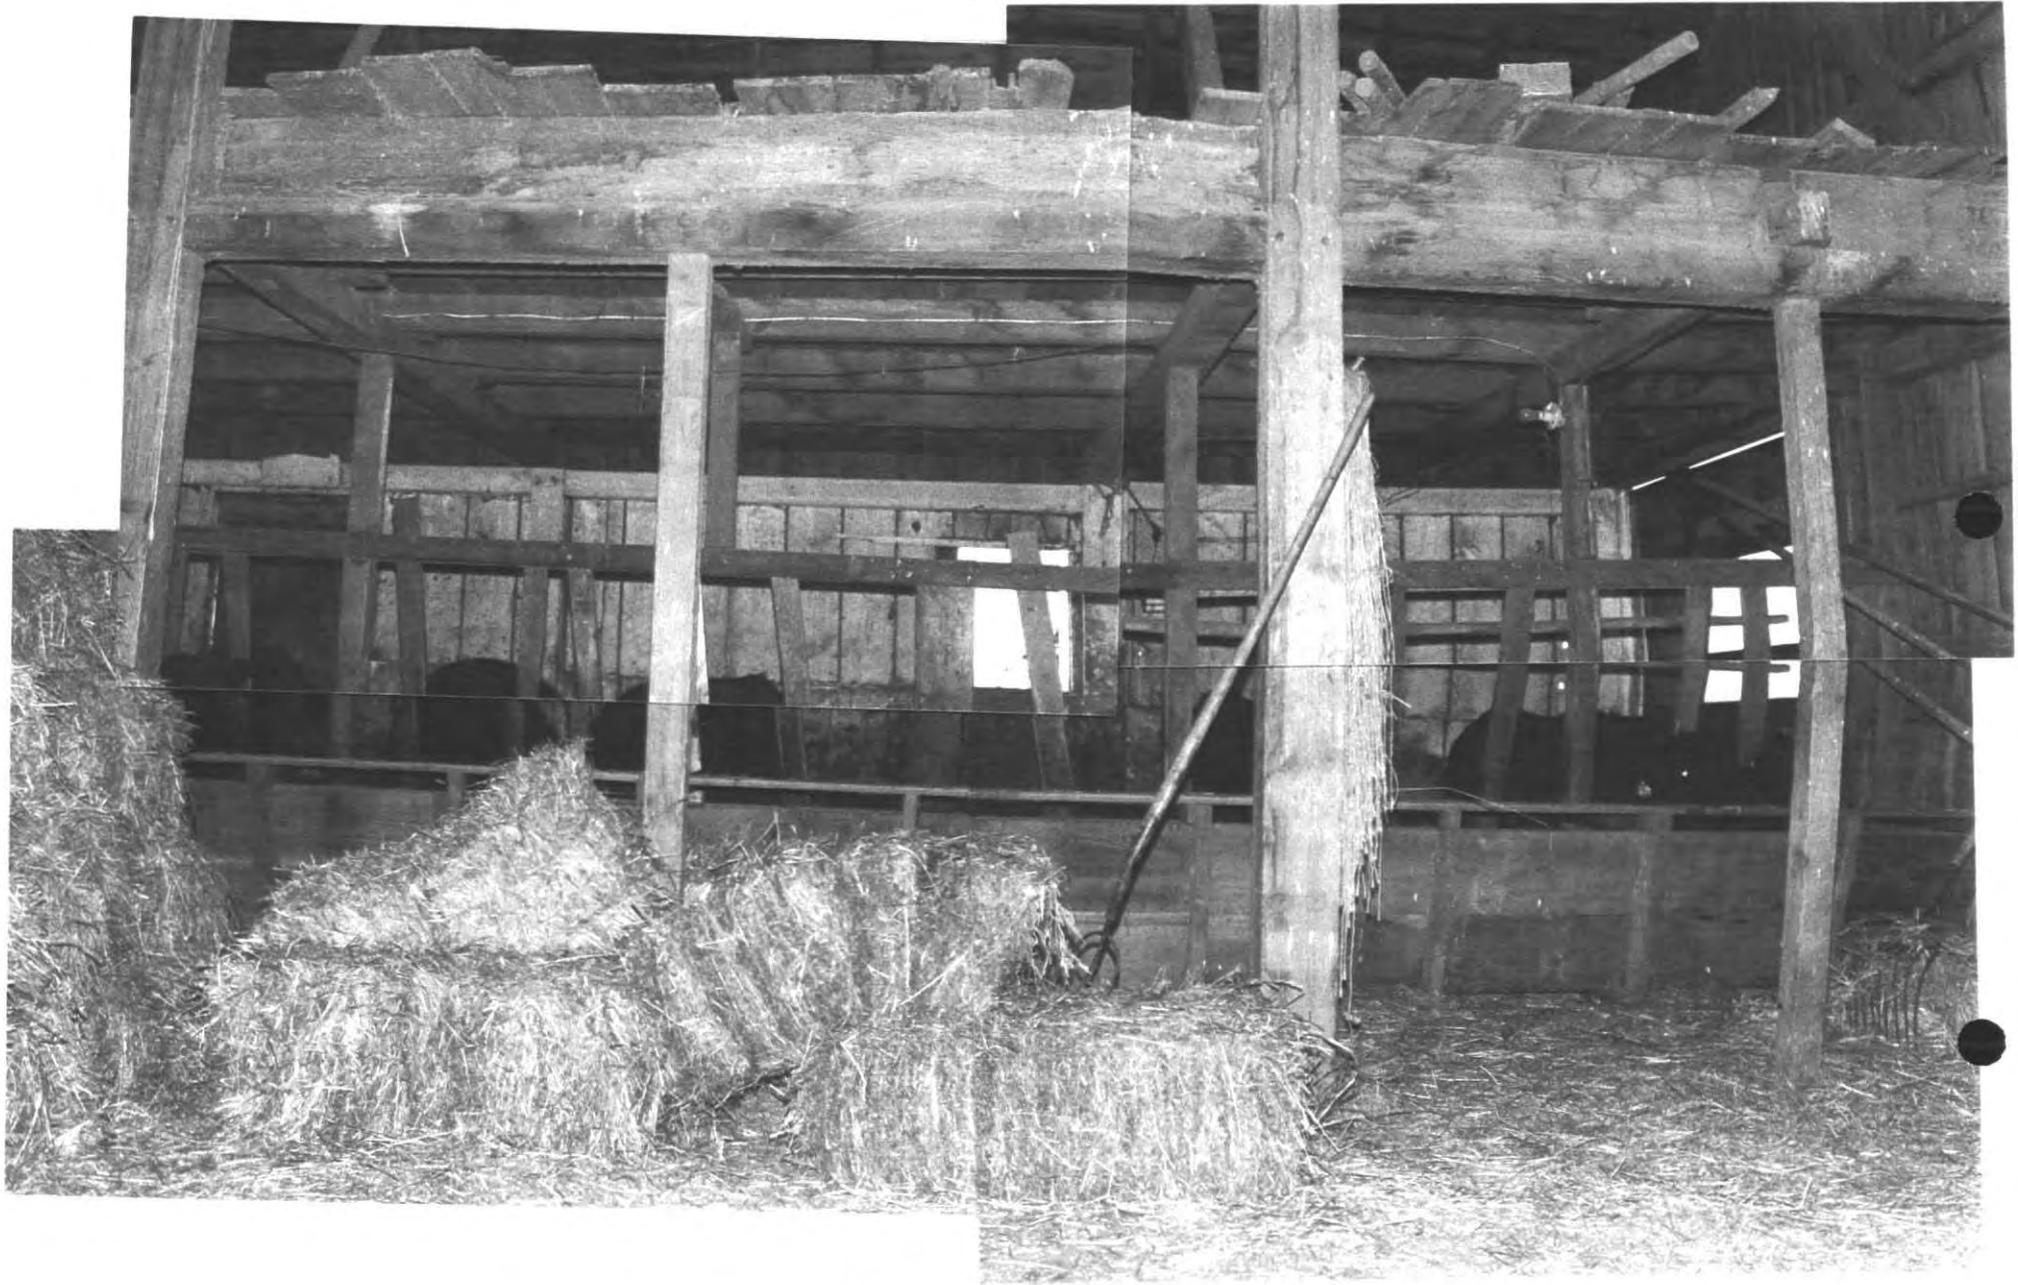
The interior of the barn (looking skewed because these are four photos arranged together to produce a panoramic view).

For a brief period --2-3 years--in the World War II era, my family had a dairy and supplied milk to customers in Spangle and to the two stores. For that reason, whitewash was applied to interior walls, and milking machine piping installed. This is a post and beam barn, 50 x 50 feet in dimension. The boards on the leans are all different lengths.

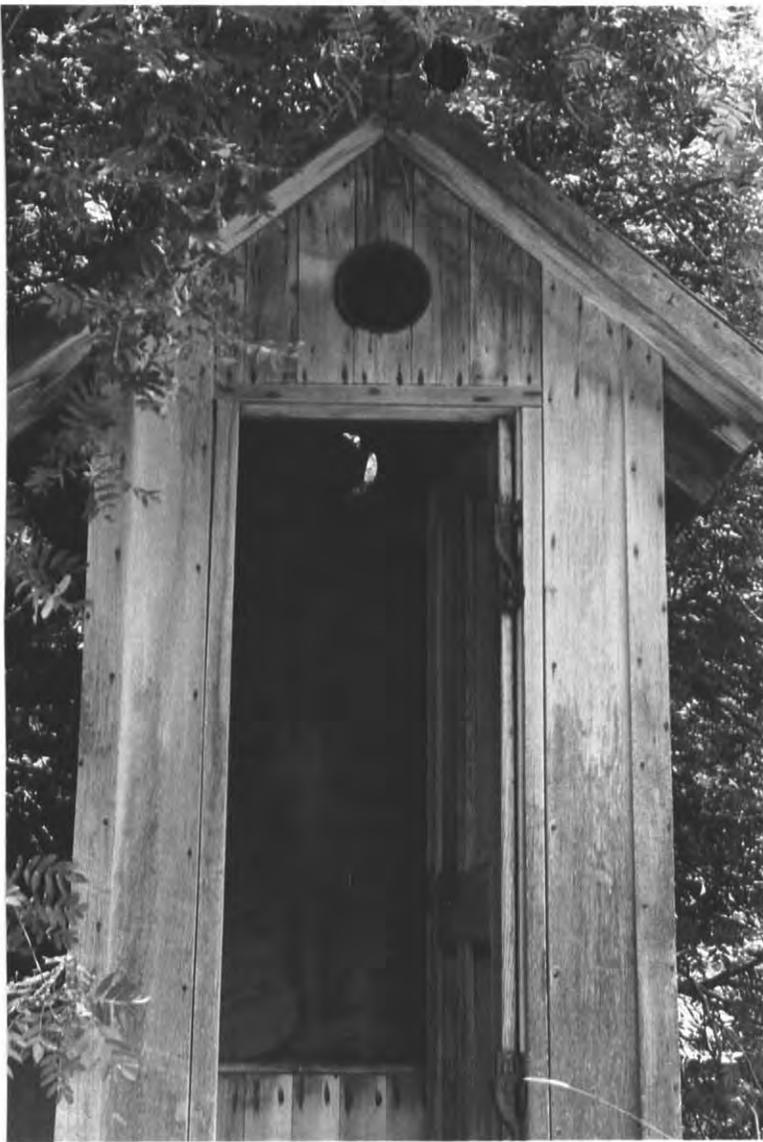
●
Out House
Sun over door
crescent moon
on back

This is a "hole and a half"-- it includes a child's toilet.

Note the ornate curving iron spring-loaded hinges near the top and the bottom of the door, eliminating the need for a spring coil to bring the door shut after each use .

Use of these hinges necessitated carving out their shape into the wood to make room for them to "close" when the door came shut. I suspect the outhouse predates the barn.
