# Historic Property Report

**Historic Name:** Audubon Park Restroom

Property ID: 706338

**Common name:** Audubon Park Restroom  
**Date recorded:** 7/12/2016  
**Field Recorder:** Stephen Emerson  
**Field Site number:** SRS-2  
**SHPO Determination**

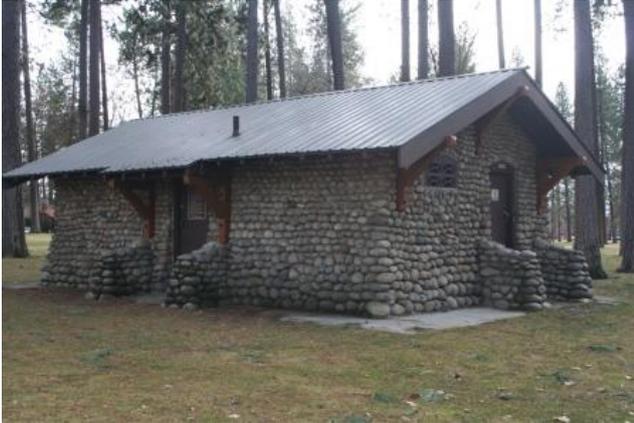
SRS-2a.JPG

**Physical description:** This cobblestone building has a gabled roof covered with a standing seam metal roof that features exposed rafter ends, knee braces and fascia boards in the gable eaves. The exterior walls are clad with uniform round or oval stones, mostly granite. The stones were carefully placed so that very little mortar is visible. There are three entries, one at each end for boys and girls facilities, and one on the north elevation that accesses a central utility and maintenance room. The central door has an extension of the roof as a canopy, supported by knee braces. Each entry is flanked by cobblestone half-walls. There are five windows, one each near the boys and girls entries, and three on the south elevation. They are horizontally aligned with stone segmental arches. They were once larger, and rectangular, but at a later date they were partially filled in with cobblestones. The lines between the original openings and the filled in portions are visible. The remaining opening at the top is filled with ornamental cinder blocks with spaces for allowing light. These replace what were probably originally vertical iron bars (if childhood memory serves me).
