Historic Property Report

Historic Name: Glass Park Restroom

Inventory Details - 7/15/2016

Common name: Glass Park Restroom
Date recorded: 7/15/2016
Field Recorder: Stephen Emerson
Field Site number: SRS-14
SHPO Determination

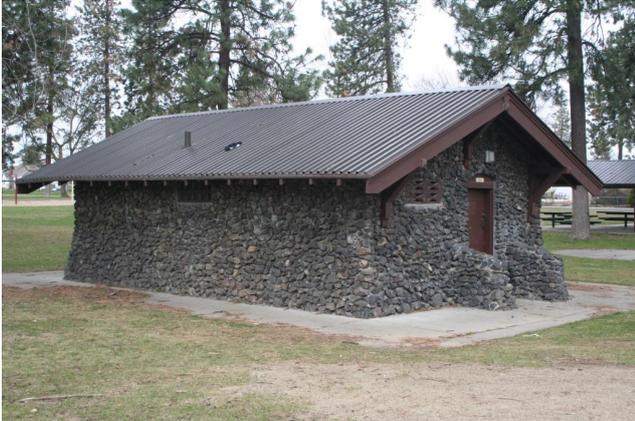
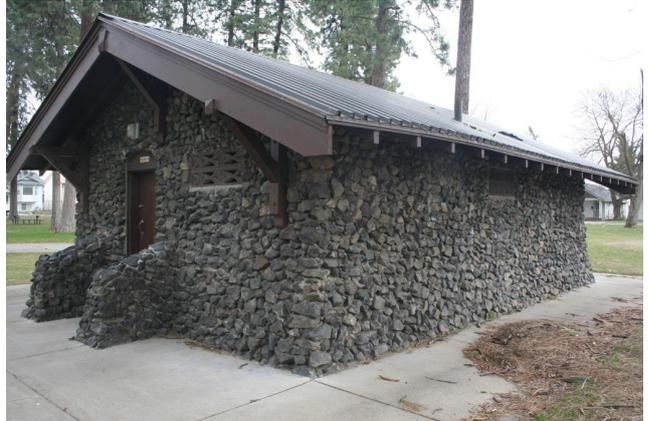
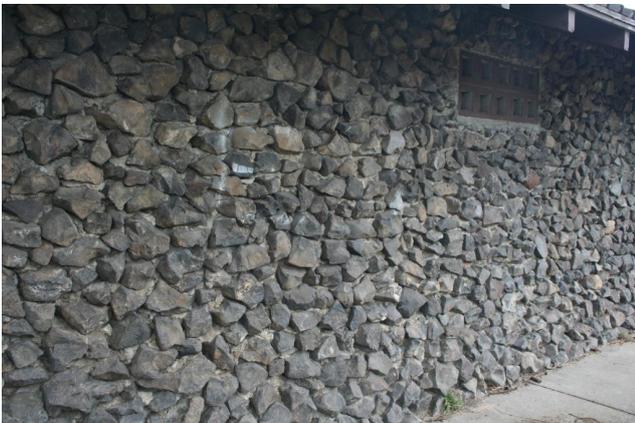
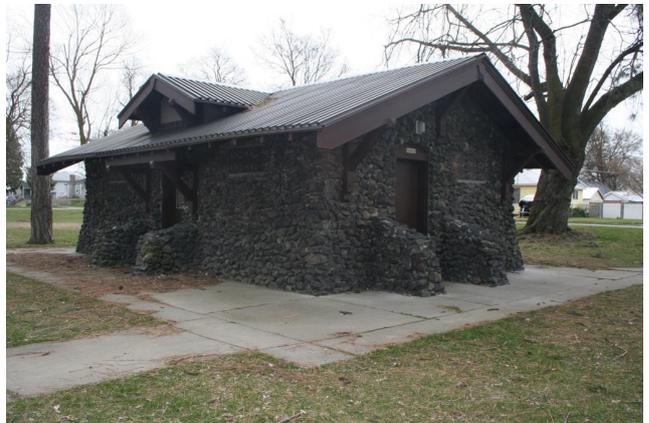
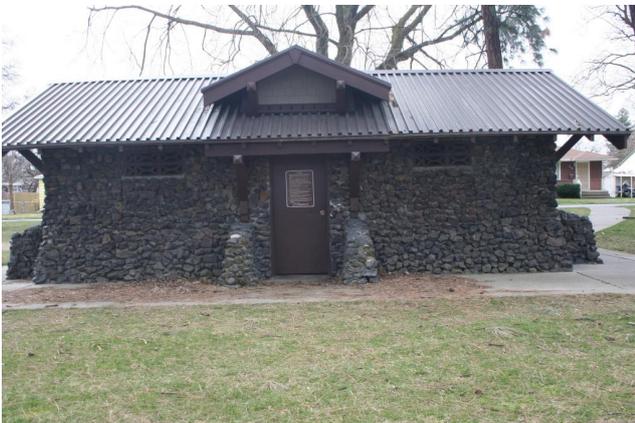
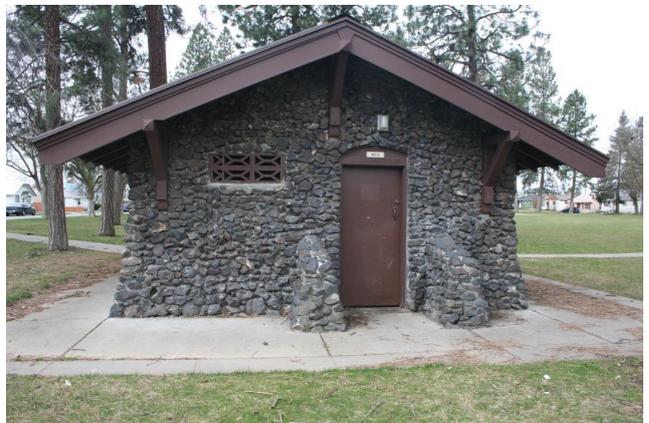
Physical description: This basalt rubble building has a gabled roof covered with a standing seam metal roof that features exposed rafter ends and knee braces and fascia boards in the gable eaves. The exterior walls are clad with uniform pieces of broken basalt. The stones were carefully placed so that very little mortar is visible. There are three entries, one at each end for boys and girls facilities, and one on the north elevation that accesses a central utility and maintenance room. The central door has an extension of the roof as a canopy, supported by knee braces. Additionally, there is a windowless gabled dormer above the central entry with exposed purlins and fascia boards. The gable face is clad with wood shingles. Each entry is flanked by cobblestone half-walls. There are five windows, one each near the boys and girls entries, one on the south elevation, and two on the north wall, flanking the central utility entry. They are horizontally aligned with stone segmental arches. They were once larger and rectangular, but at a later date they were partially filled in with basalt rubble. The lines between the original openings and the filled in portions are visible. The remaining opening at the top is filled with ornamental cinder blocks with spaces for allowing light. These probably replace what were originally vertical iron bars.
