United States Department of the Interior
National Park ServiceNational Register of Historic Places
Registration Form

historic name The Miller Blockother names/site number The Miller Building

street & number 808 West Soraque Avenue ☐ not for publicationcity or town Spokane ☐ vicinitystate WA code WA county Spokane code 063 zip code 99201

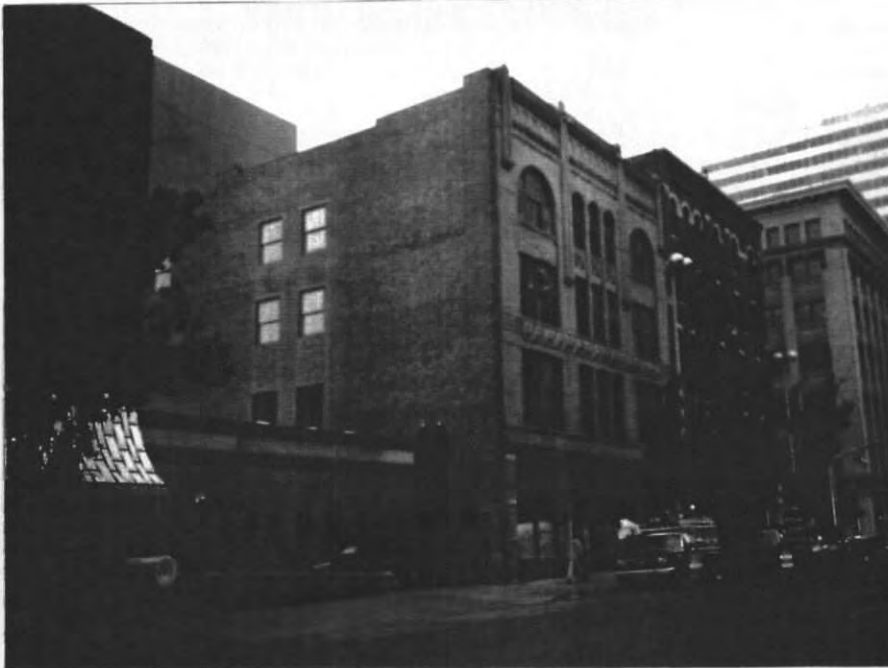
Photograph Number 3: Southwest corner of Miller Block, 1997 photo
Photograph Number 4: South facade

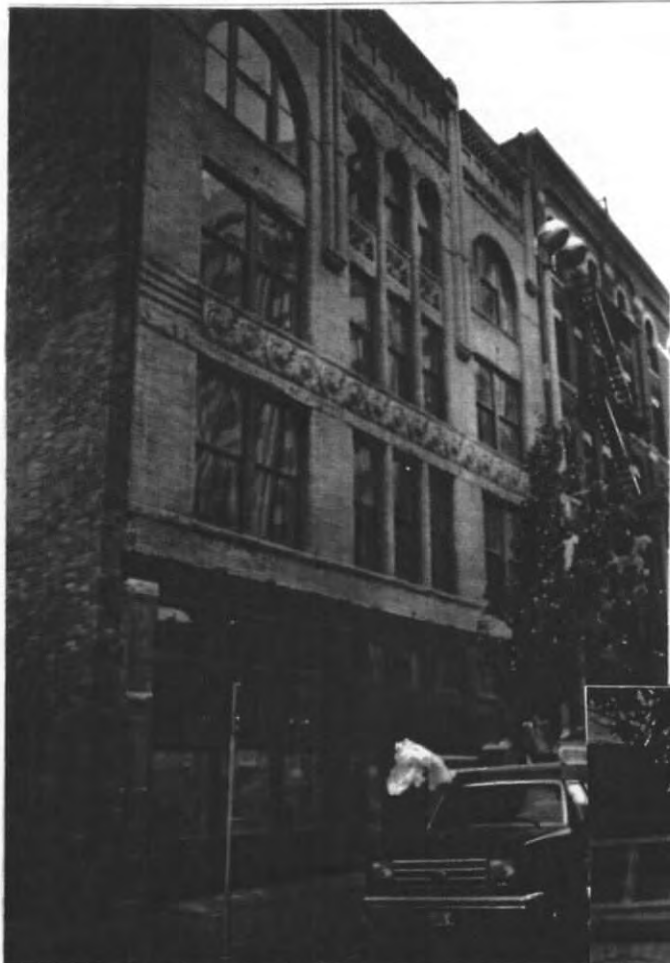
Photograph Number 5:

Southwest facade, 1997 photo

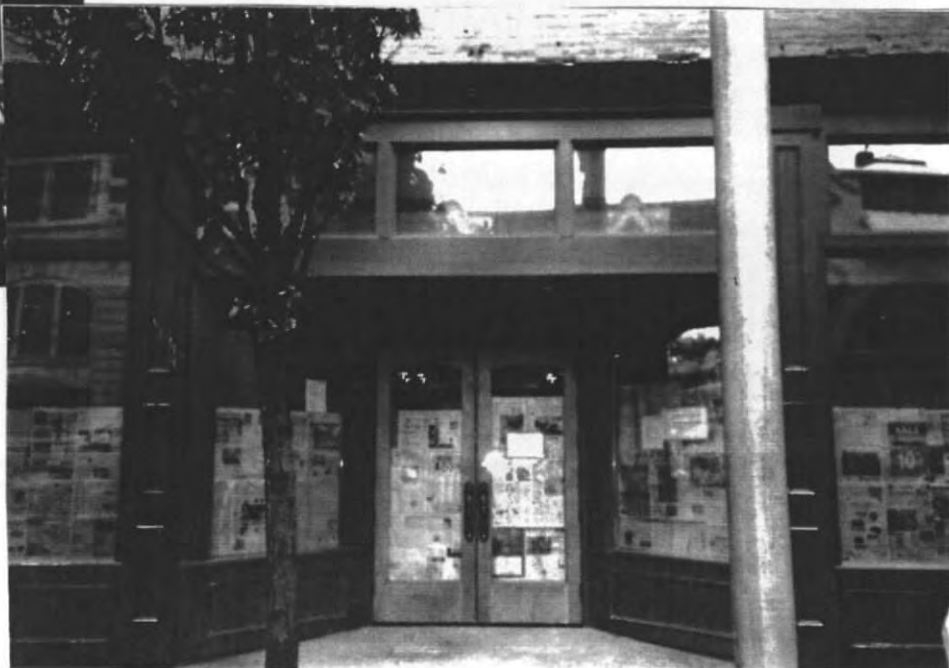
Photograph Number 6:

South facade, street-level storefront detail

symmetrically into three vertical bays by varying fenestration and projecting ornamental colonettes. The second and third floor windows are vertical, rectangular-shaped, one-over-one, double-hung wood-sash units. The fourth floor window openings form semicircular arches and feature voussoirs of rock-faced limestone. Curved molded brick reveals frame the recessed one-over-one, double-hung wood-sash windows. Curved buff-colored bricks are also used to create narrow, double pilasters (or colonettes) that rise from the third floor and continue up through the roofline. The pilasters are decorated with carved, foliated caps and supports. The second and third floors are separated by a deep, continuous band of rinceau sculpted in sandstone. The terra cotta rinceau rests on a stringcourse of rock-faced sandstone that forms lintels over second-floor windows. A narrower stone stringcourse runs above the rinceau and creates third-floor window sills. Recessed foliated panels separate third and fourth-floor window openings. The street-level facade of the Miller Building features a centrally placed canted bay with contemporary-compatible storefront design incorporating plate glass windows, wood-paneled bulkheads, transom lights and arched double-entry doors.

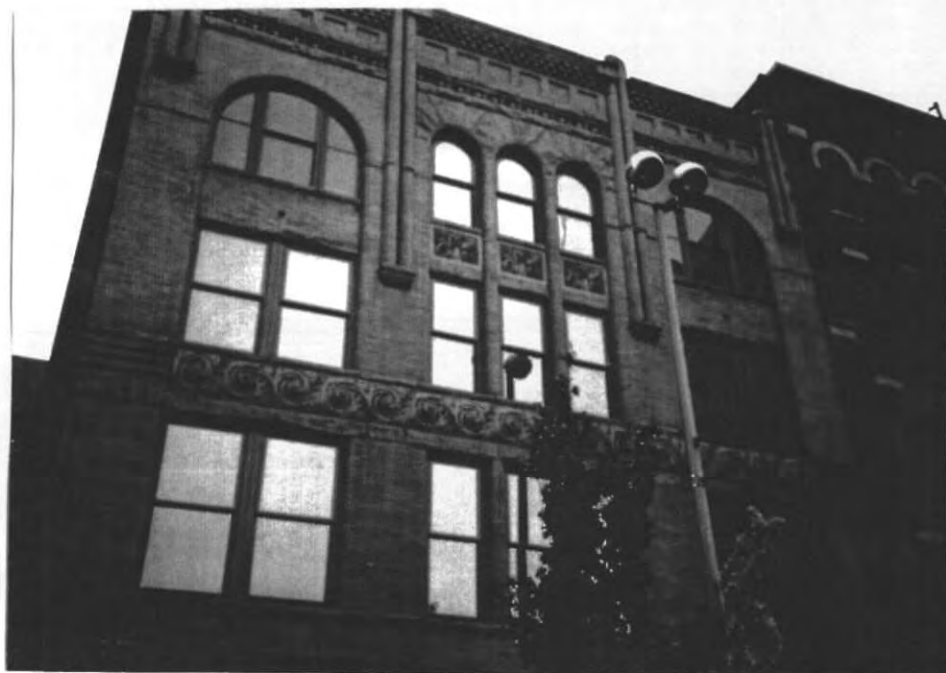
Photograph Number 7: South facade upper-level detail, 1997 photo
Photograph Number 8: South facade street-level storefront detail

The four-story Miller Block rises nearly 65 feet to a corbelled parapet that conceals a flat roof of built-up tar. The parapet is accentuated by a slightly taller center section and consists of a narrow foliated sandstone course, a frieze band of recessed panels, a decorative course of corbelled brick, and sandstone coping. Behind the parapet, the roof slopes slightly toward the rear and supports an elevator-stairwell tower, an additional exit at the northeast corner of the roof, mechanical and air conditioning shafts and two enclosed, vented skylights. Red bricks laid in a common bond measure sixteen to twenty inches thick and form the building's structural, brick-bearing walls. The north, east and west elevations are clad in red brick veneer while the building's facade is covered with decorative buff-colored pressed brick veneer. Found in Spokane only on the Miller Block, the narrow, elongated buff-colored bricks are an unusual size measuring one and three-quarters inches high by thirteen inches long. The facade of the Miller Building is divided

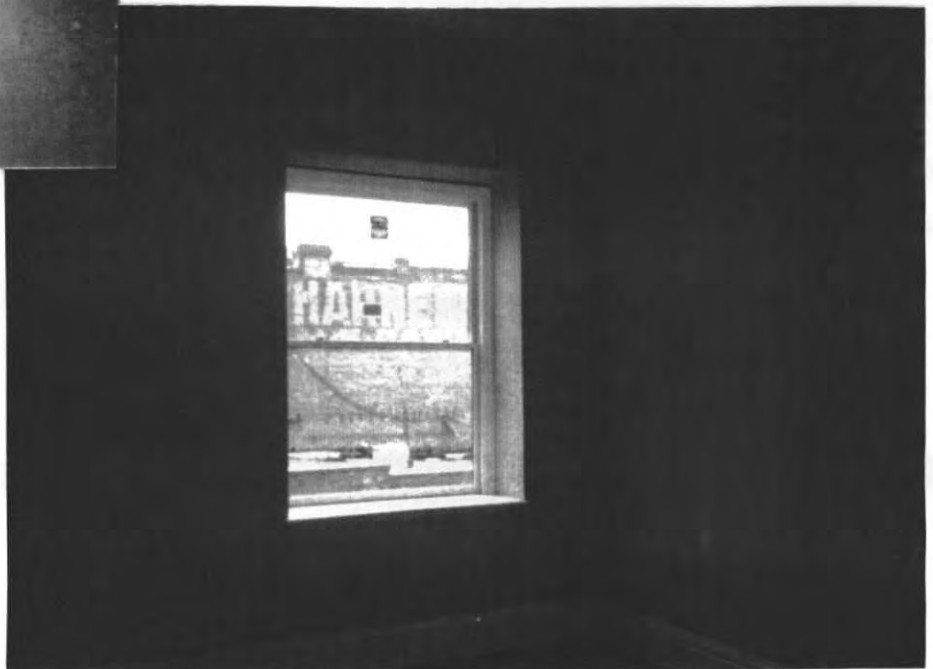
Photograph Number 16:

Fourth floor hotel room, west wall and window

The west elevation of the Miller Building is clad in red brick veneer laid in a stretcher bond with paired corbelled wall projections at the first and second floor juncture, and supports three rectangular, one-over-one, double-hung wood-sash windows at each level on the second, third and fourth floors. A brick bridge controlled by the adjacent underground parking facility and designed to hold fluorescent signage is attached to the west wall and joins the Miller Block to the three-story building to the west. The rear, north elevation of the Miller Block faces a narrow alleyway and consists of symmetrically placed one-over-one, aluminum-clad, wood-sash windows at the second, third and fourth levels. The ground-floor windows are fixed multi-paned metal units with wire safety-glass panes.
