Historic Property Report

Historic Name: Riverside Memorial Park Cinerarium

Property ID: 706410

Common name: Riverside Memorial Park Cinerarium
Date recorded: 7/16/2016
Field Recorder: Stephen Emerson
Field Site number: SRS-27
SHPO Determination

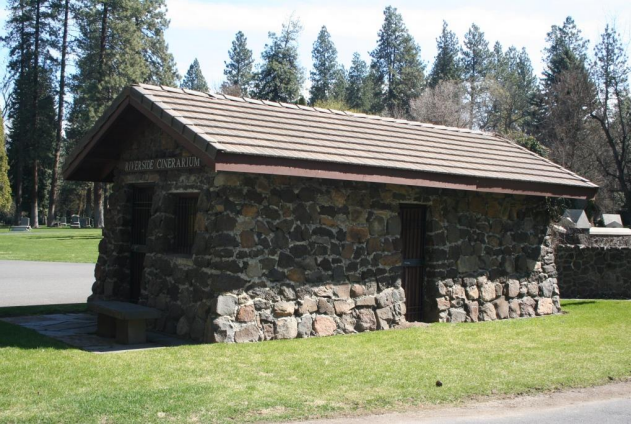
SRS-27a.JPG

Physical description: This is a simple rectangular building with a gabled roof. The exterior walls are constructed of mortared basalt rubble, randomly coursed with the mortar quite visible. The roof is covered with wood shakes and has a clay tile roof ridge. The eaves are wide and unenclosed, revealing no exposed rafter ends or purlins. There are three thick wood panel doors, on three sides, and two window openings that are covered. All fenestration is protected by iron bars.
